## INSPECTION REPORT

Project: <b>Greenacres School</b>	Date: <b>10/03/19</b>
Address: <b>41 Huntington Avenue, Scarsdale NY 10583</b>	Job ID / MU #:
Client: <b>Park East Construction</b>	Weather: <b>Sunny (AM)</b>

Inspection Type: <b>Noise and Dust Monitoring</b>	Contractor: <b>Park East</b>
Present At Site: <b>7:00AM</b>	Sub-Contractor:
General Area: <b>Northern Yard of School</b>	CM/Designer:
Specific Location: <b>Northern Side of school 1st, 2nd floor, Basement</b>	
Last Inspection:	Building Code Section:
Reviewed	Drawings:
Approved	Submittals
	Other:

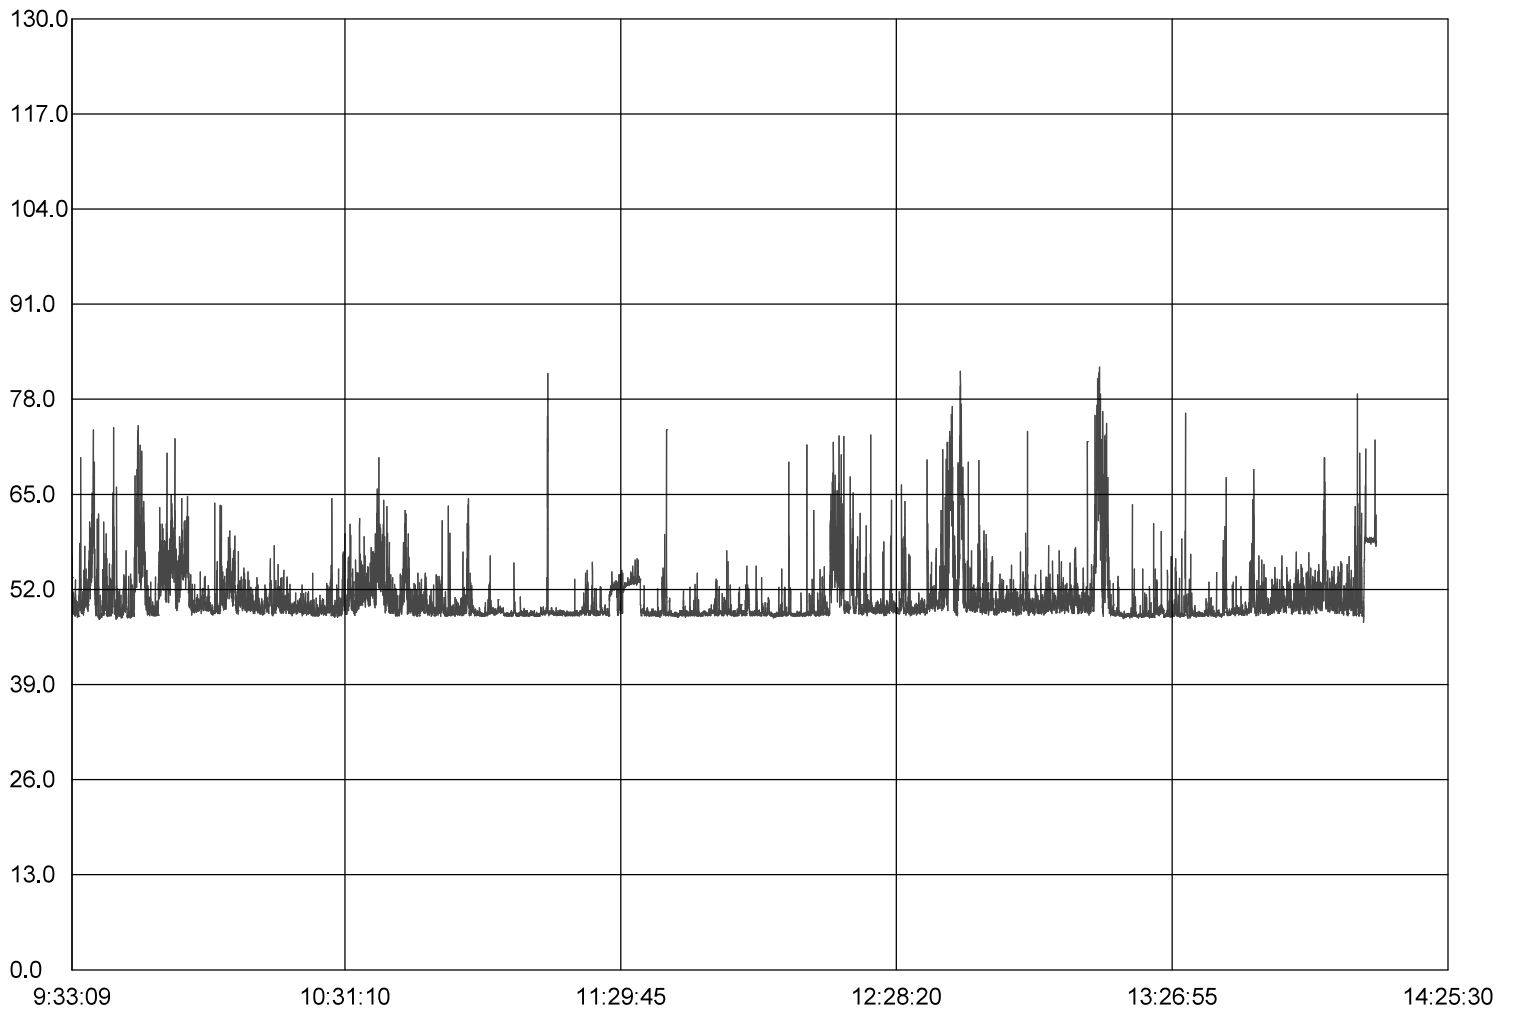
**BASEMENT HALLWAY AM 1**

Standard Sound Level Meter RealTime Graph  
Time: 2019-10-3 14:25:52

Start Time: 03-10-2019,9:33:09  
Maxnum: 82.40 03-10-2019,13:11:29  
Minnum: 47.50 03-10-2019,14:07:36  
Sample Rate: 1.00  
Average: 50.69

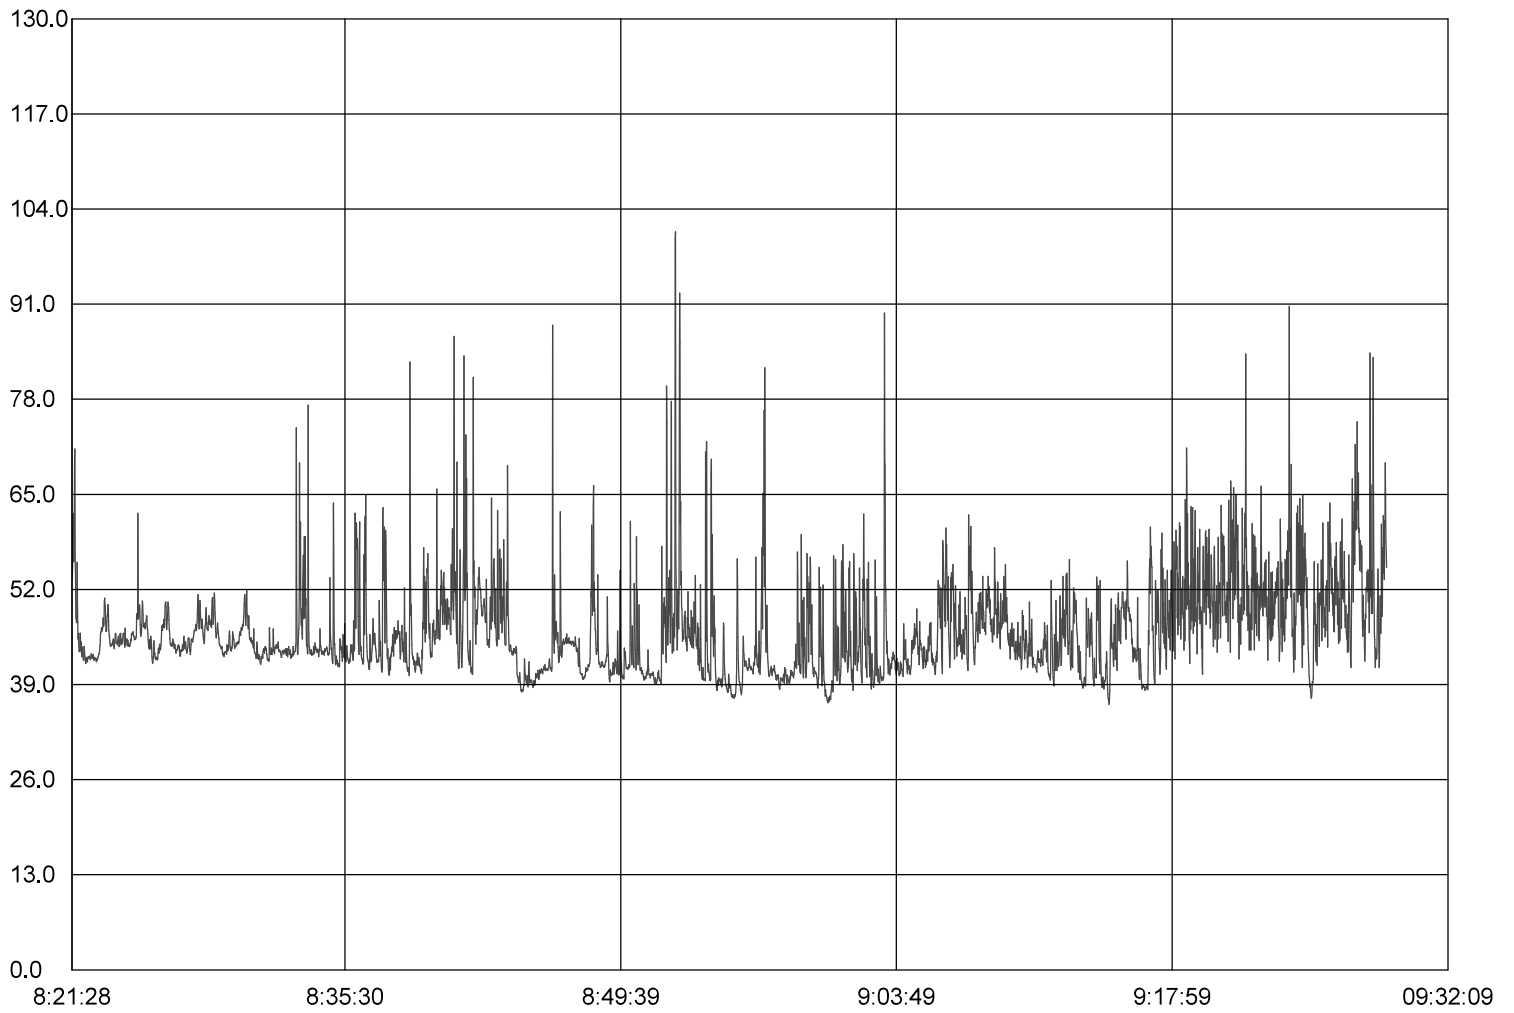
**BASEMENT HALLWAY AM 1**

Standard Sound Level Meter RealTime Graph  
Time: 2019-10-3 14:25:40

Start Time: 03-10-2019,8:21:28  
Maxnum: 100.90 03-10-2019,8:52:28  
Minnum: 36.30 03-10-2019,9:14:45  
Sample Rate: 1.00  
Average: 46.27

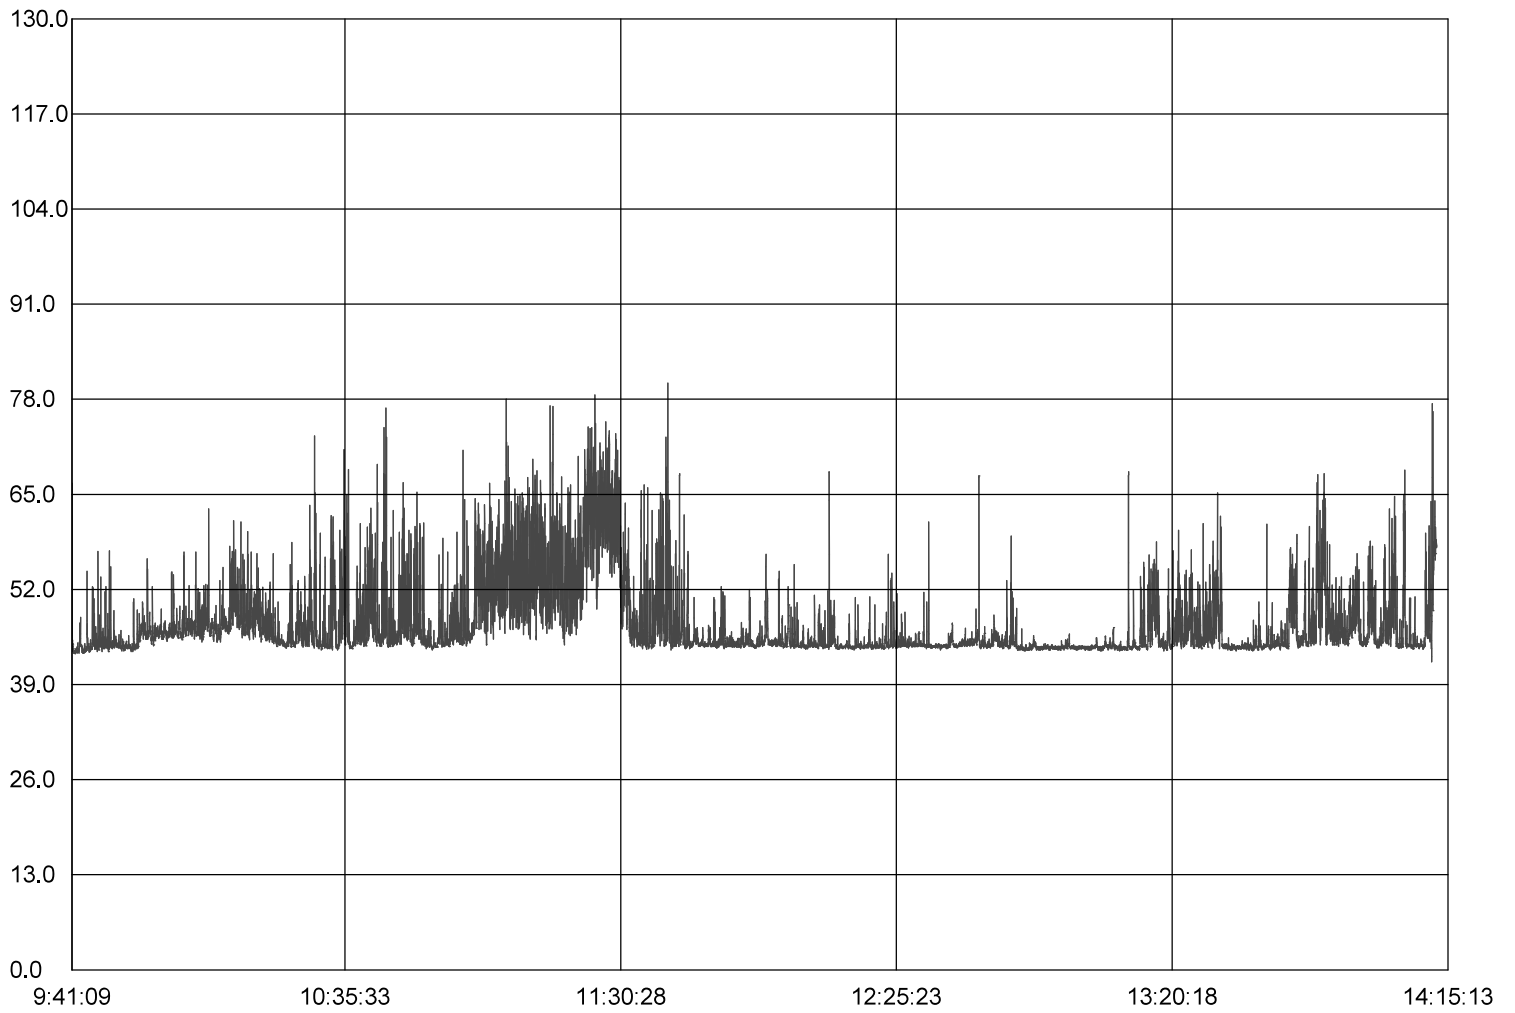
**Library AM 2**

Standard Sound Level Meter RealTime Graph  
Time: 2019-10-3 14:23:30

Start Time: 03-10-2019,9:41:09  
Maxnum: 80.20 03-10-2019,11:39:52  
Minnum: 42.10 03-10-2019,14:12:01  
Sample Rate: 1.00  
Average: 47.18

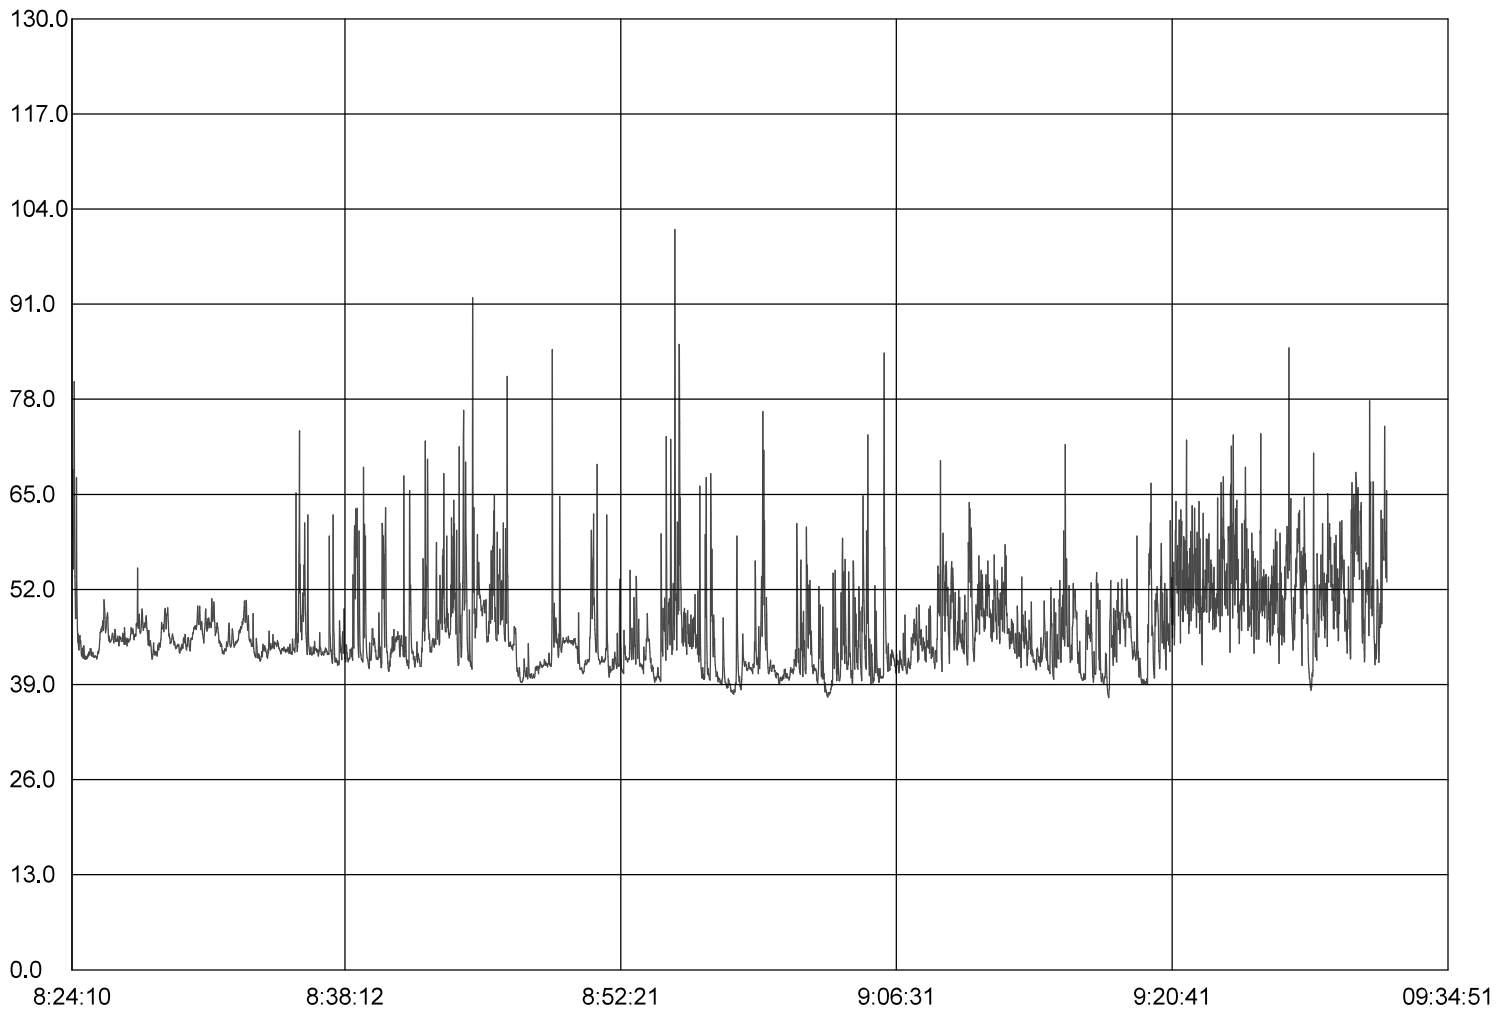
**Library AM Data**

Standard Sound Level Meter RealTime Graph  
Time: 2019-10-3 14:22:35

Start Time: 03-10-2019,8:24:10  
Maxnum: 101.20 03-10-2019,8:55:08  
Minnum: 37.20 03-10-2019,9:17:26  
Sample Rate: 1.00  
Average: 46.71
