INSPECTION REPORT

Project: Greenacres School	Date: 10/04/19
Address: 41 Huntington Avenue, Scarsdale NY 10583	Job ID / MU #:
Client: Park East Construction	Weather: Sunny

Inspection Type: Noise and Dust Monitoring	Contractor: Park East
Present At Site: 7:00AM	Sub-Contractor:
General Area: Northern Yard of School	CM/Designer:
Specific Location: Northern Side of school 1st, 2nd floor, Basement	
Last Inspection:	Building Code Section:
Reviewed	Drawings:
Approved	Submittals
	Other:

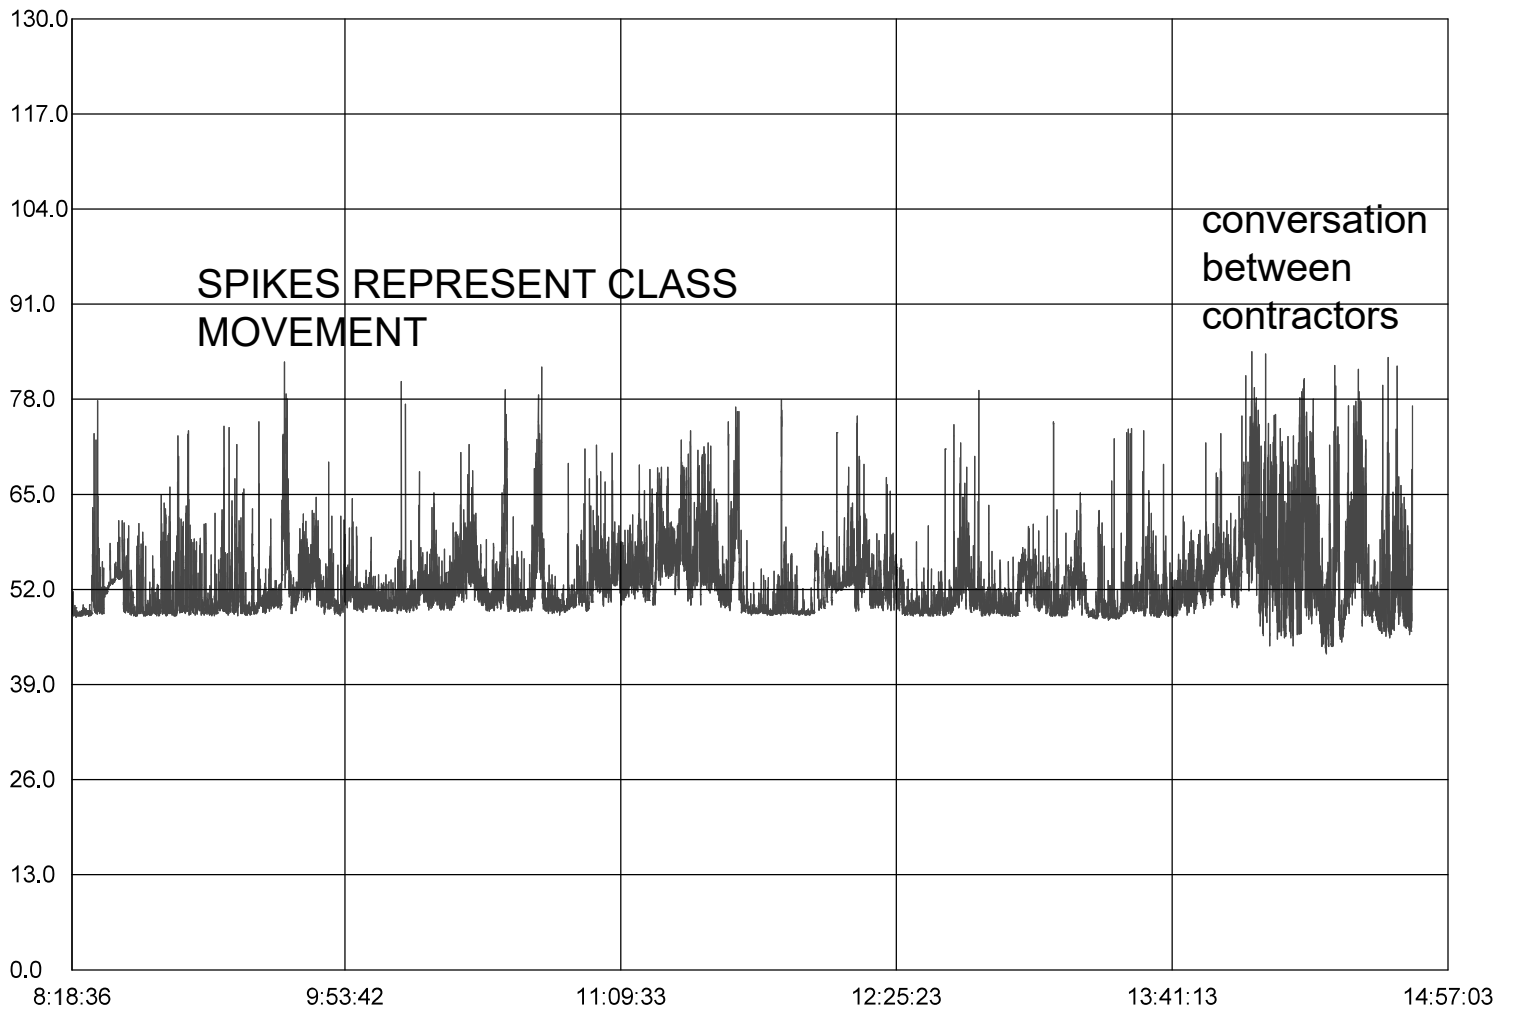
Standard Sound Level Meter RealTime Graph
Time: 2019-10-4 14:55:55

Noise caused by ongoing construction in the perimeter of the school was monitored using a sound level meter. Readings were taken in the library, next to the work performed today.

An Average noise level of 52.77 dB was measured for the day

Start Time: 04-10-2019,8:18:36
Maxnum: 84.50 04-10-2019,14:03:09
Minnum: 43.20 04-10-2019,14:23:38
Sample Rate: 1.00
Average: 52.77
