## INSPECTION REPORT

| Project: <b>Greenacres School</b> | Date: <b>10/08/19</b> |

| Inspection Type: <b>Noise and Dust Monitoring</b> | Contractor: <b>Park East</b> |

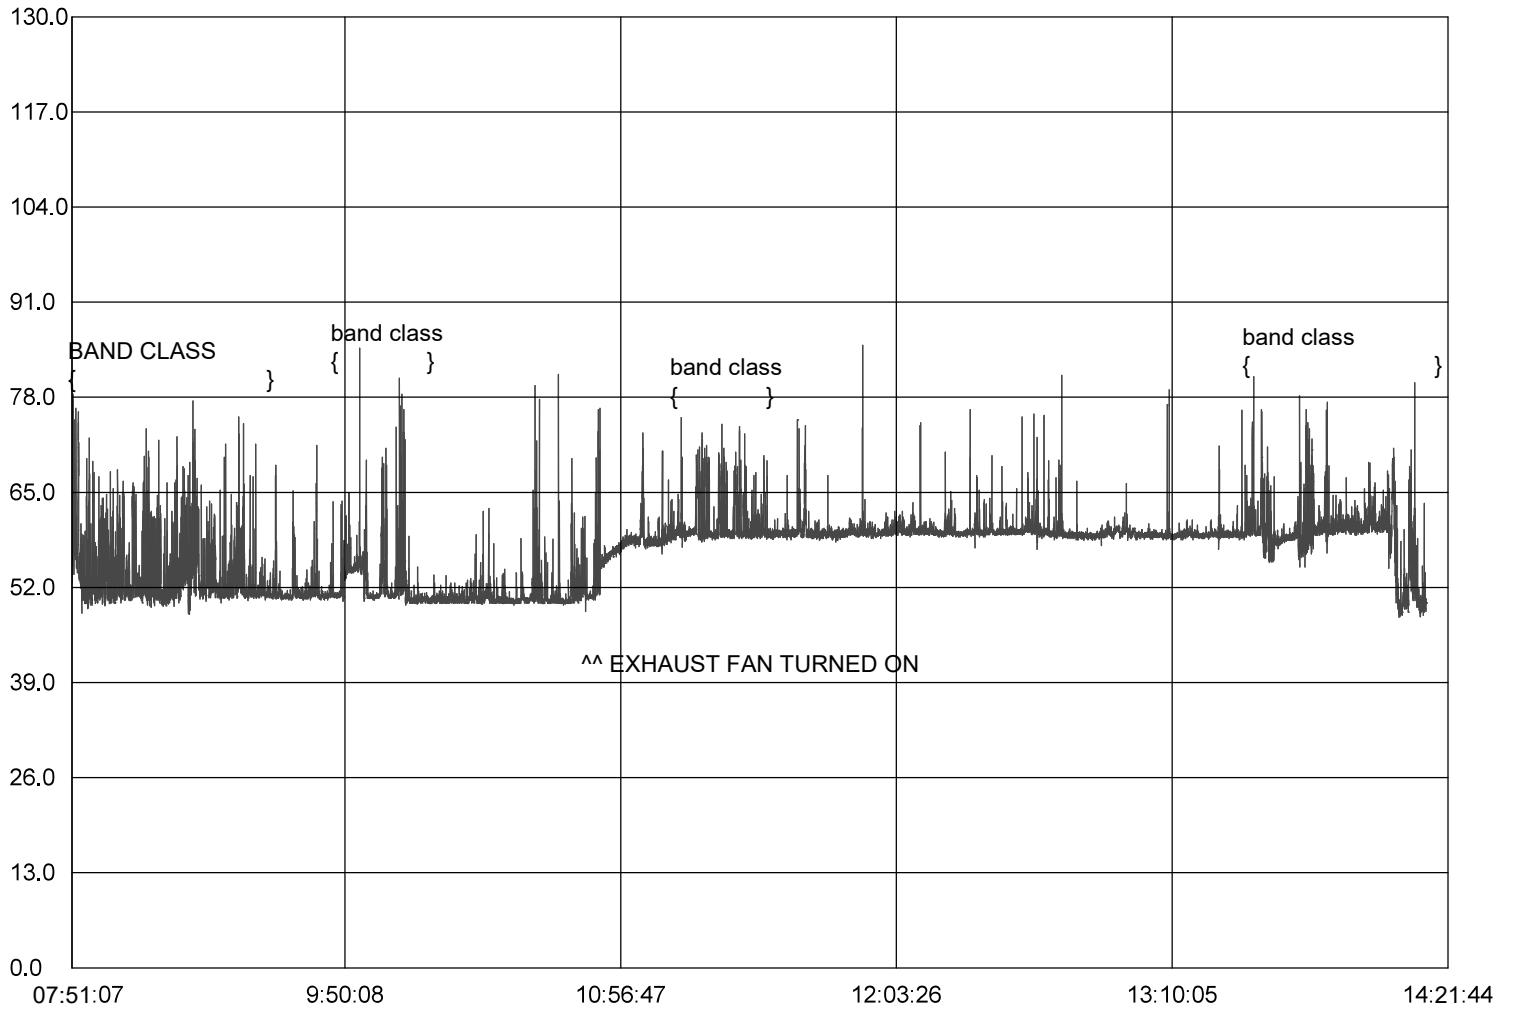
BASEMENT HALLWAY

Noise caused by ongoing construction in the perimeter of the school was monitored using a sound level meter. Readings were taken in the basement hallway (20 feet from construction), next to the work performed today.

An Average noise level of **56.80 dB** was measured for the day

Standard Sound Level Meter RealTime Graph  
Time: 2019-10-8 14:25:7

Start Time: 08-10-2019,07:51:07  
Maxnum: 85.10 08-10-2019,11:55:19  
Minnum: 47.90 08-10-2019,14:21:58  
Sample Rate: 1.00  
Average: 56.80
