INSPECTION REPORT

Project: GREENACRES SCHOOL	Date: OCTOBER 15, 2019
Address: 41 HUNTINGTON AVENUE, SCARSDALE NY 10583	Job ID / MU #:
Client: PARK EAST CONSTRUCTION	Weather: SUNNY

Inspection Type: NOISE AND DUST MONITORING	Contractor: PARK EAST
Present At Site: 7:00 AM	Sub-Contractor:
General Area: NORTHERN YARD OF SCHOOL	CM/Designer:
Specific Location: NORTHERN SIDE OF SCHOOL 1st fl, 2nd fl, BASEMENT	
Last Inspection:	Building Code Section:
Reviewed Approved	Drawings:
	Submittals
	Other:

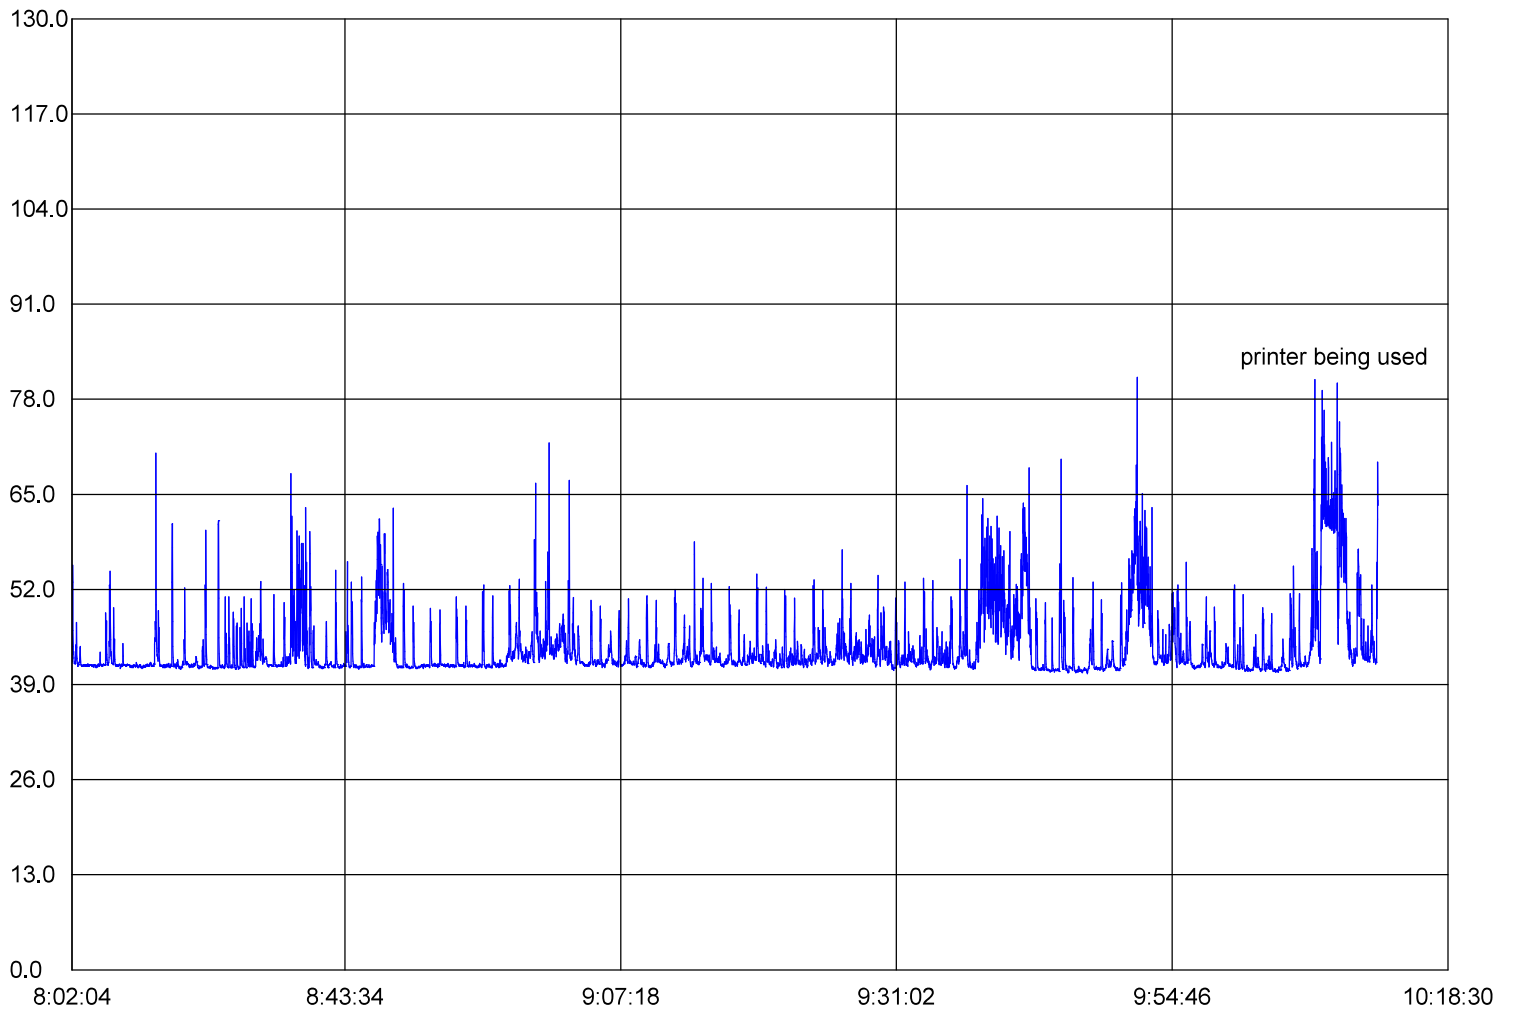
BASEMENT HALLWAY AM #1

Standard Sound Level Meter RealTime Graph
Time: 2019-10-15 14:48:54

Start Time: 15-10-2019,8:02:04
Maxnum: 81.00 15-10-2019,9:51:46
Minnum: 40.50 15-10-2019,9:47:29
Sample Rate: 1.00
Average: 43.98

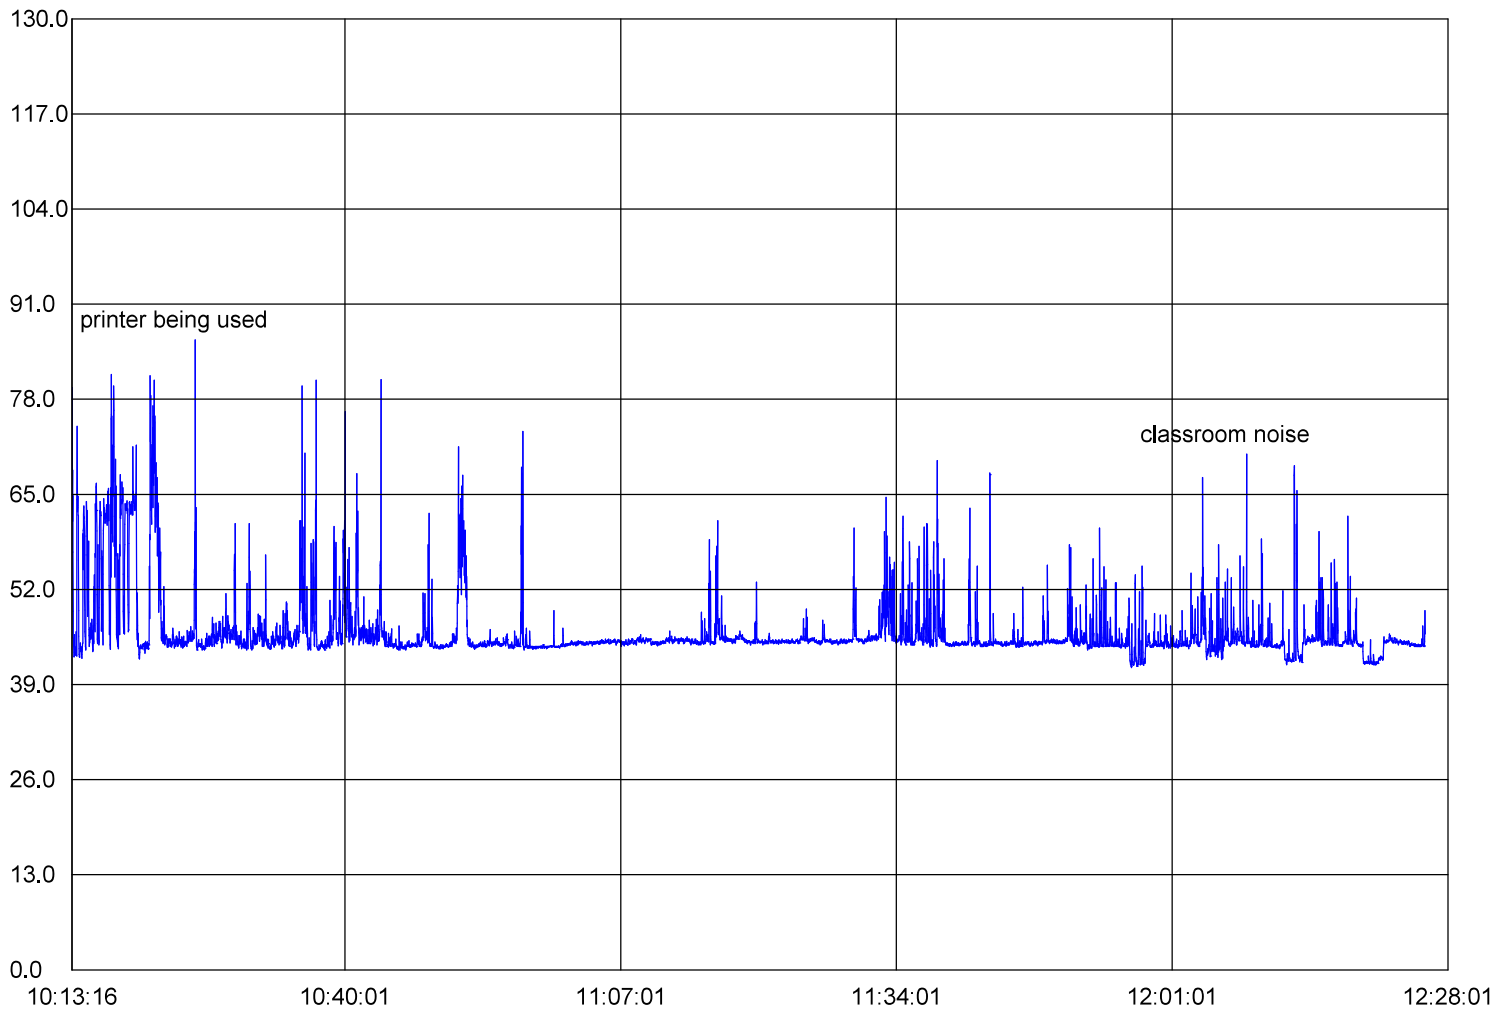
BASEMENT HALLWAY #2

Standard Sound Level Meter RealTime Graph
Time: 2019-10-15 14:49:7

Start Time: 15-10-2019,10:13:16
Maxnum: 86.10 15-10-2019,10:25:21
Minnum: 41.30 15-10-2019,11:57:02
Sample Rate: 1.00
Average: 46.10

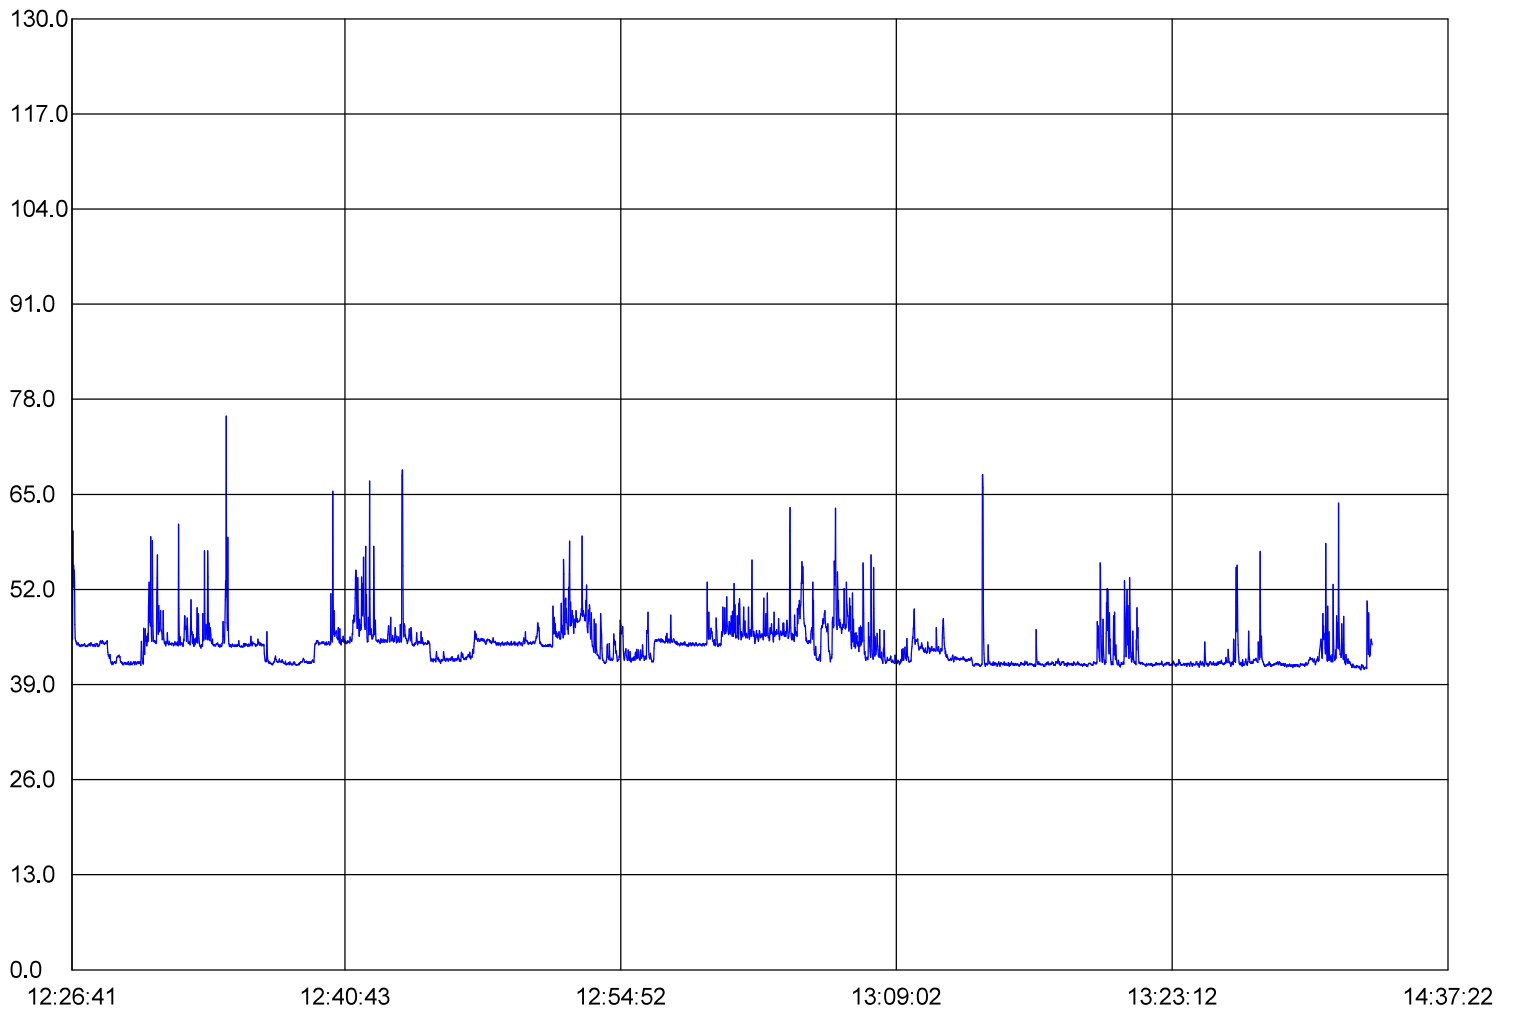
BASEMENT HALLWAY #3

Standard Sound Level Meter RealTime Graph
Time: 2019-10-15 14:49:23

Start Time: 15-10-2019,12:26:41
Maxnum: 75.70 15-10-2019,12:34:37
Minnum: 41.00 15-10-2019,13:32:54
Sample Rate: 1.00
Average: 44.18

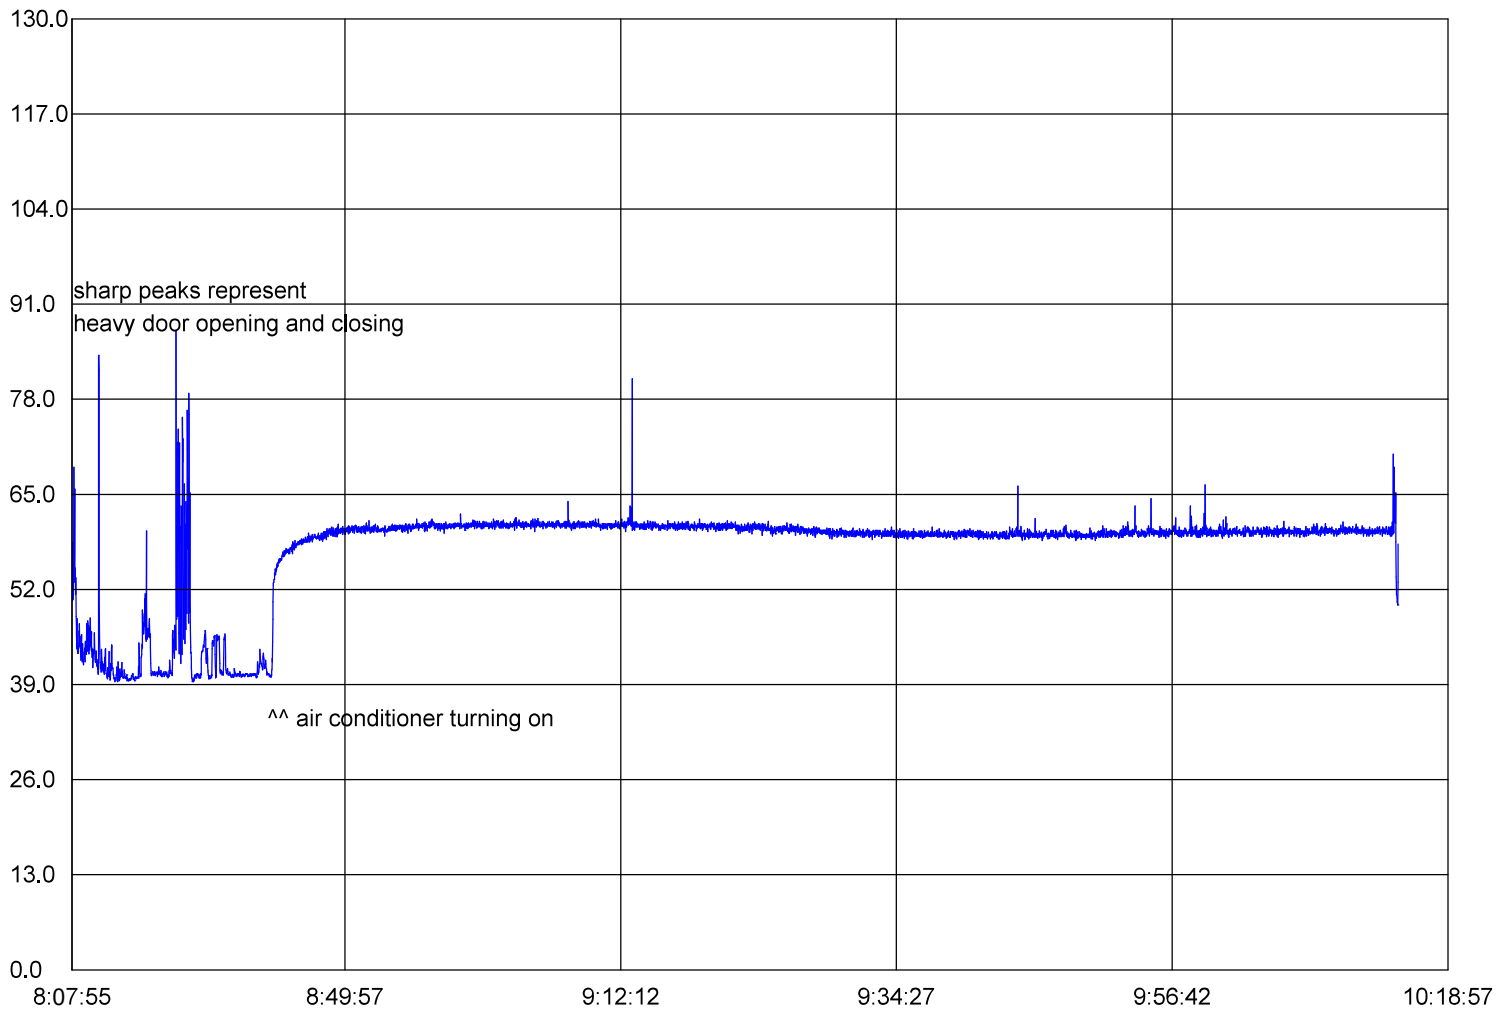
2nd floor storage #1

Standard Sound Level Meter RealTime Graph
Time: 2019-10-15 14:53:12

Start Time: 15-10-2019,8:07:55
Maxnum: 87.40 15-10-2019,8:36:20
Minnum: 39.40 15-10-2019,8:31:24
Sample Rate: 1.00
Average: 57.46

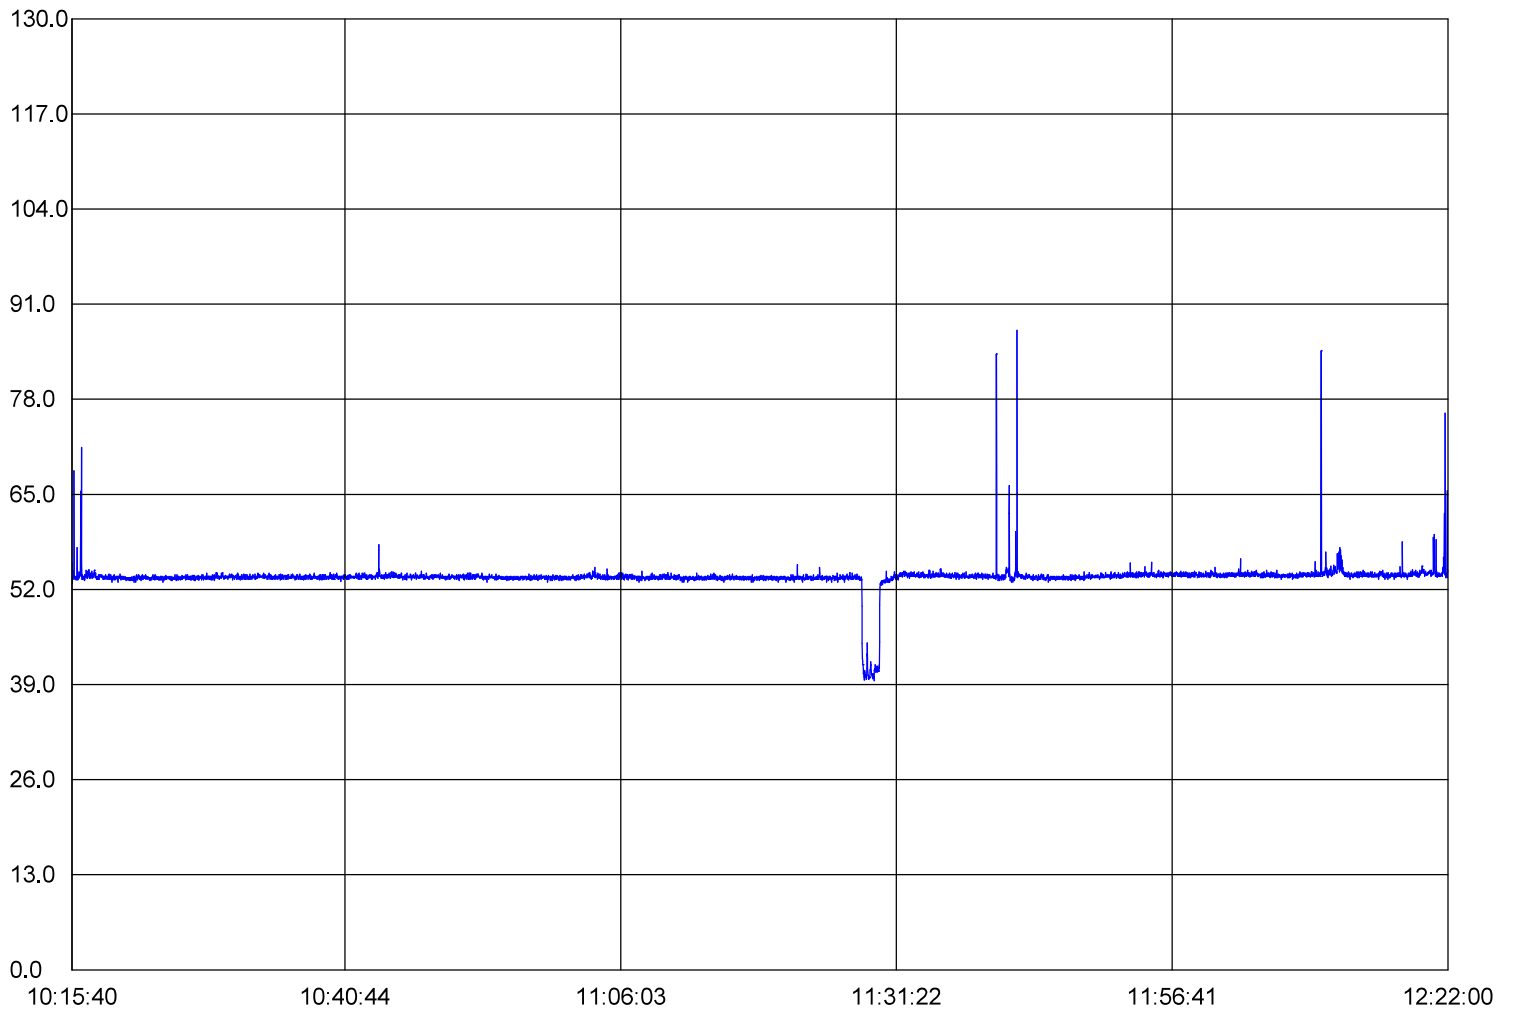
2nd floor storage 2

Standard Sound Level Meter RealTime Graph
Time: 2019-10-15 14:53:26

Start Time: 15-10-2019,10:15:40
Maxnum: 87.40 15-10-2019,11:42:27
Minnum: 39.50 15-10-2019,11:29:20
Sample Rate: 1.00
Average: 53.65

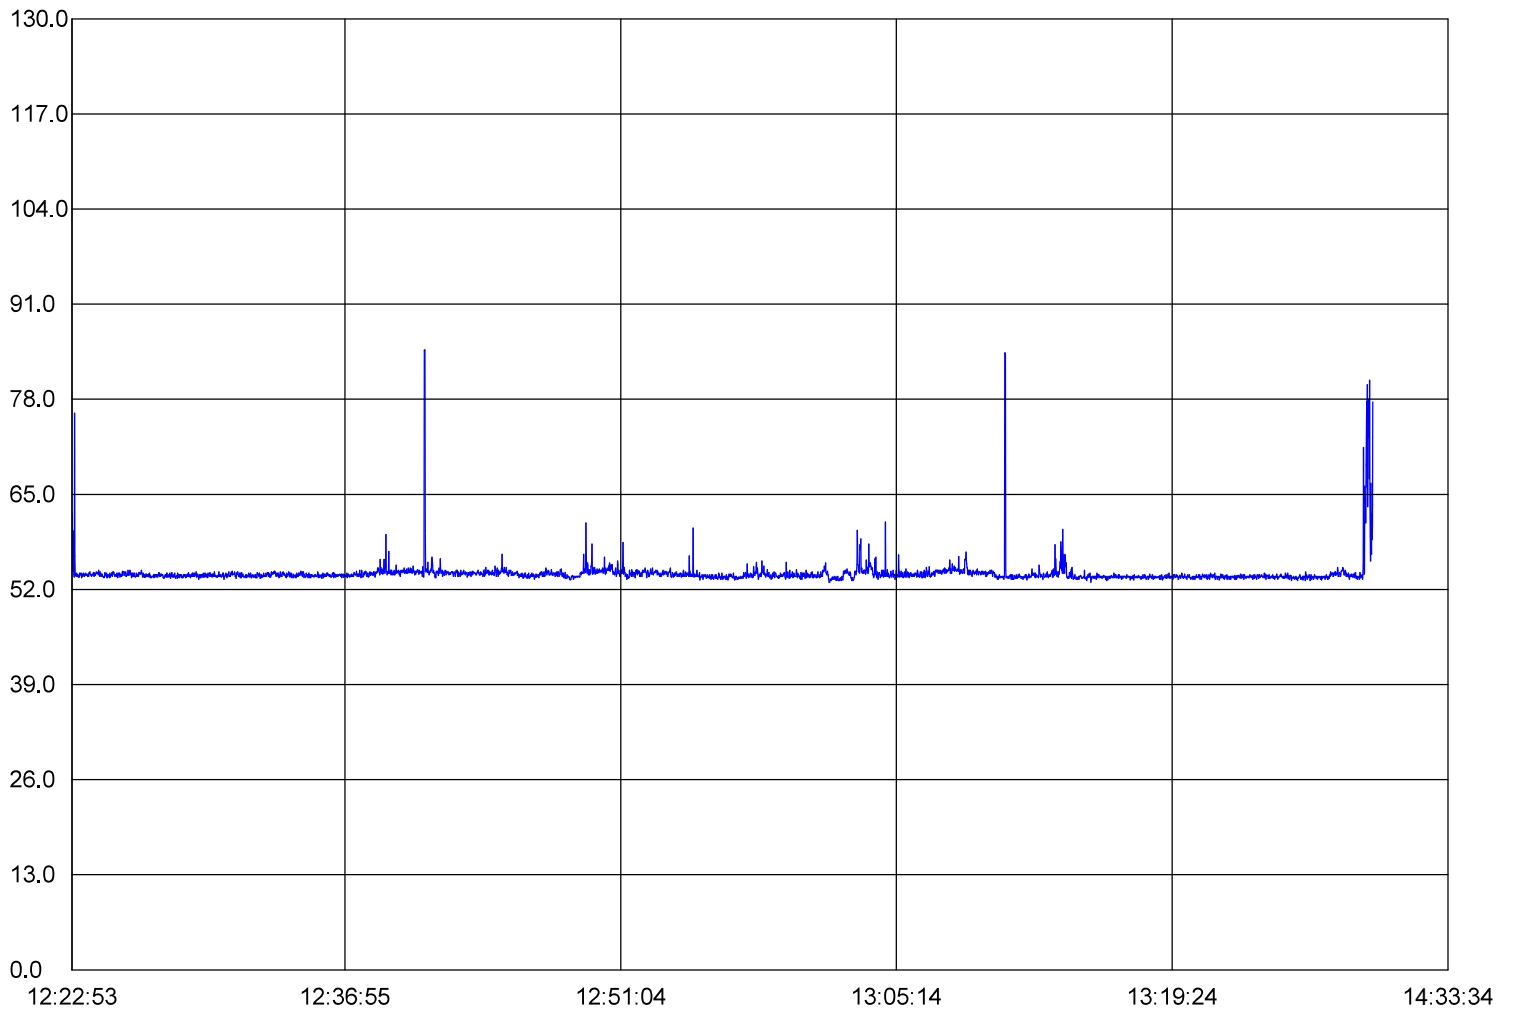
2nd floor storage 3

Standard Sound Level Meter RealTime Graph
Time: 2019-10-15 14:53:42

Start Time: 15-10-2019,12:22:53
Maxnum: 84.70 15-10-2019,12:40:59
Minnum: 53.00 15-10-2019,13:01:47
Sample Rate: 1.00
Average: 54.18
