Project: Greenacres School	Date: 10/16/19
Address: 41 Huntington Avenue, Scarsdale NY 10583	Job ID/ MU#:
Client: Park East Construction	Weather: Cloudy

Inspection Type: Noise and Dust Monitoring	Contractor: Park East
Present At Site: 7:00AM	Sub-Contractor:
General Area: Northern Yard of School	CM/Designer:
Specific Location: Northern Side of school 1st, 2nd floor, Basement	
Last Inspection:	Building Code Section:
Reviewed	Drawings:
Approved	Submittals
	Other:

INSPECTION REPORT

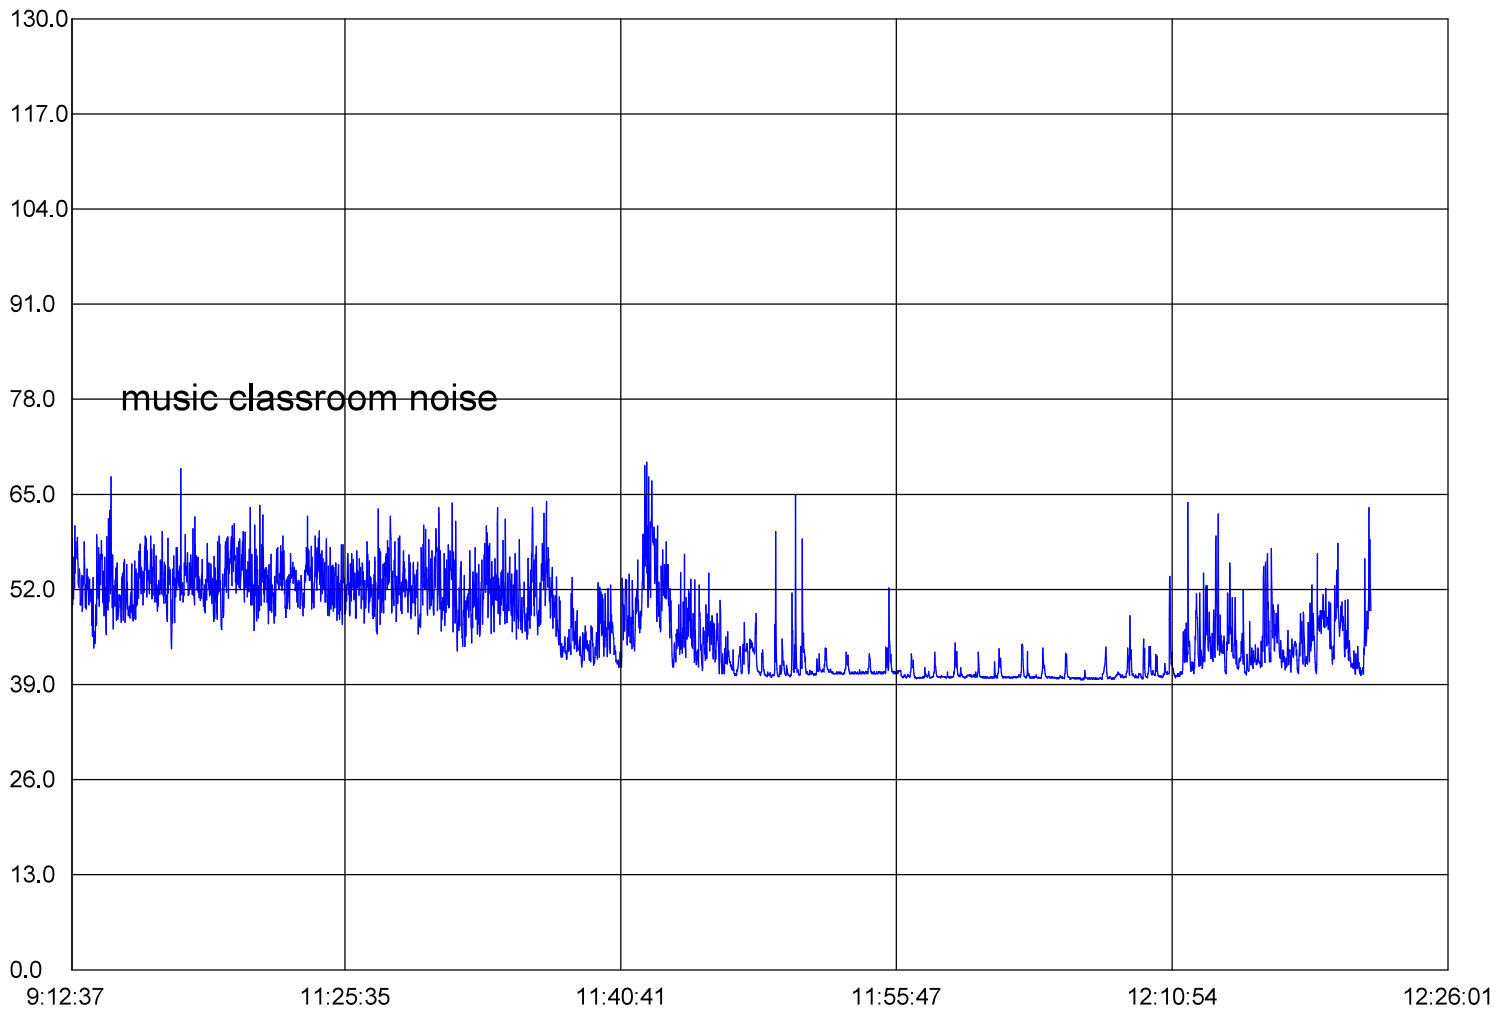
BASEMENT HALLWAY 1

Start Time: 16-10-2019,09:12:37
Maxnum: 69.40 16-10-2019,11:42:07
Minnum: 39.60 16-10-2019,12:05:54
Sample Rate: 1.00
Average: 46.66

Standard Sound Level Meter RealTime Graph
Time: 2019-10-16 14:22:50

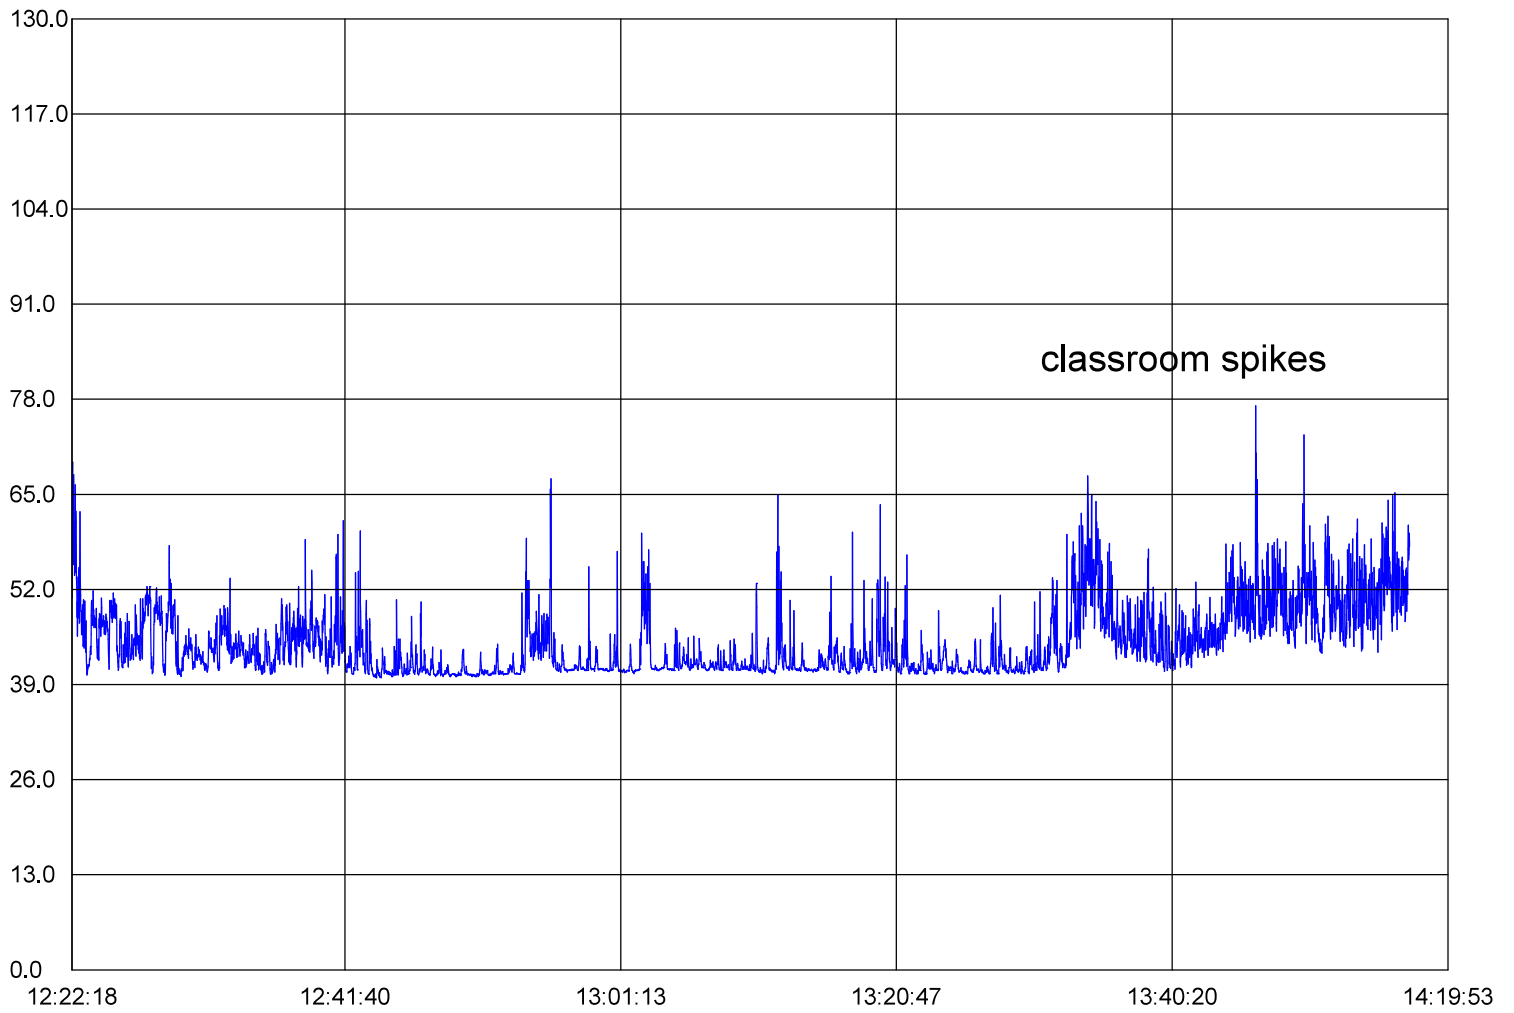
BASEMENT HALLWAY 2

Start Time: 16-10-2019,12:22:18
Maxnum: 77.10 16-10-2019,13:46:16
Minnum: 39.90 16-10-2019,12:43:55
Sample Rate: 1.00
Average: 44.60

Standard Sound Level Meter RealTime Graph
Time: 2019-10-16 14:24:20

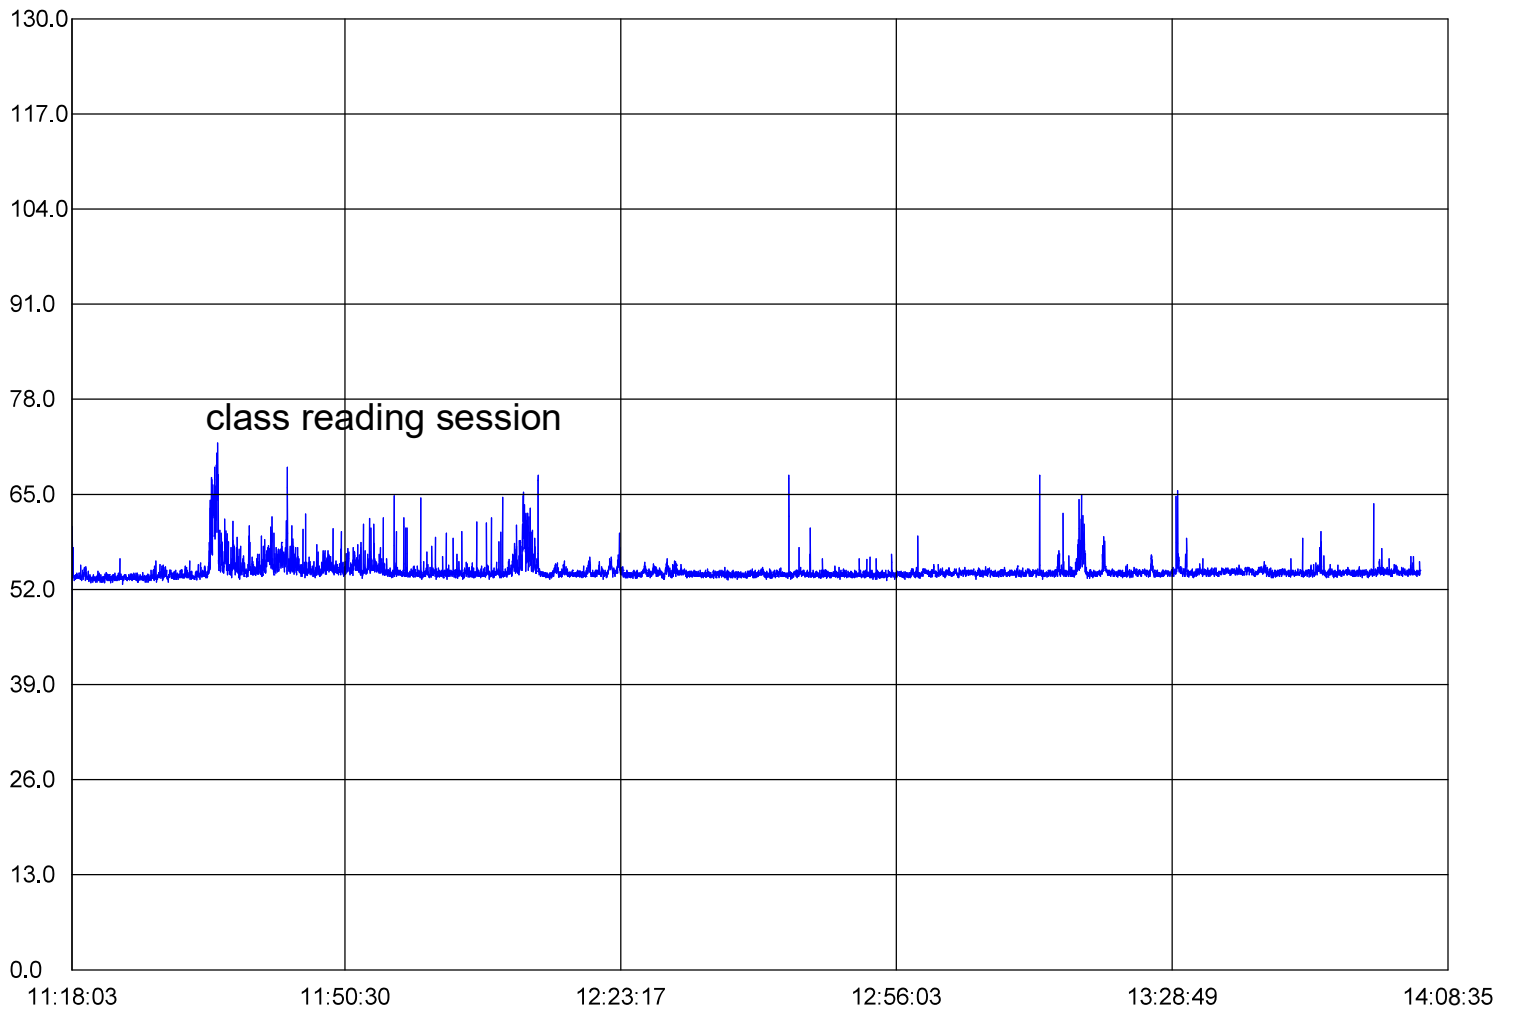
LIBRARY

Start Time: 16-10-2019,11:18:03
Maxnum: 72.00 16-10-2019,11:35:23
Minnum: 49.20 16-10-2019,11:18:03
Sample Rate: 1.00
Average: 54.50
