MUNICIPAL
TESTING LABORATORY, INC.

INSPECTION REPORT

Project: Greenacres School	Date: 10/18/19
Address: 41 Huntington Avenue, Scarsdale NY 10583	Job ID/ MU#:
Client: Park East Construction	Weather: Cloudy

Inspection Type: Noise and Dust Monitoring	Contractor: Park East
Present At Site: 7:00AM	Sub-Contractor:
General Area: Northern Yard of School	CM/Designer:
Specific Location: Northern Side of school 1st, 2nd floor, Basement	
Last Inspection:	Building Code Section:
Reviewed	Drawings:
Approved	Submittals
	Other:

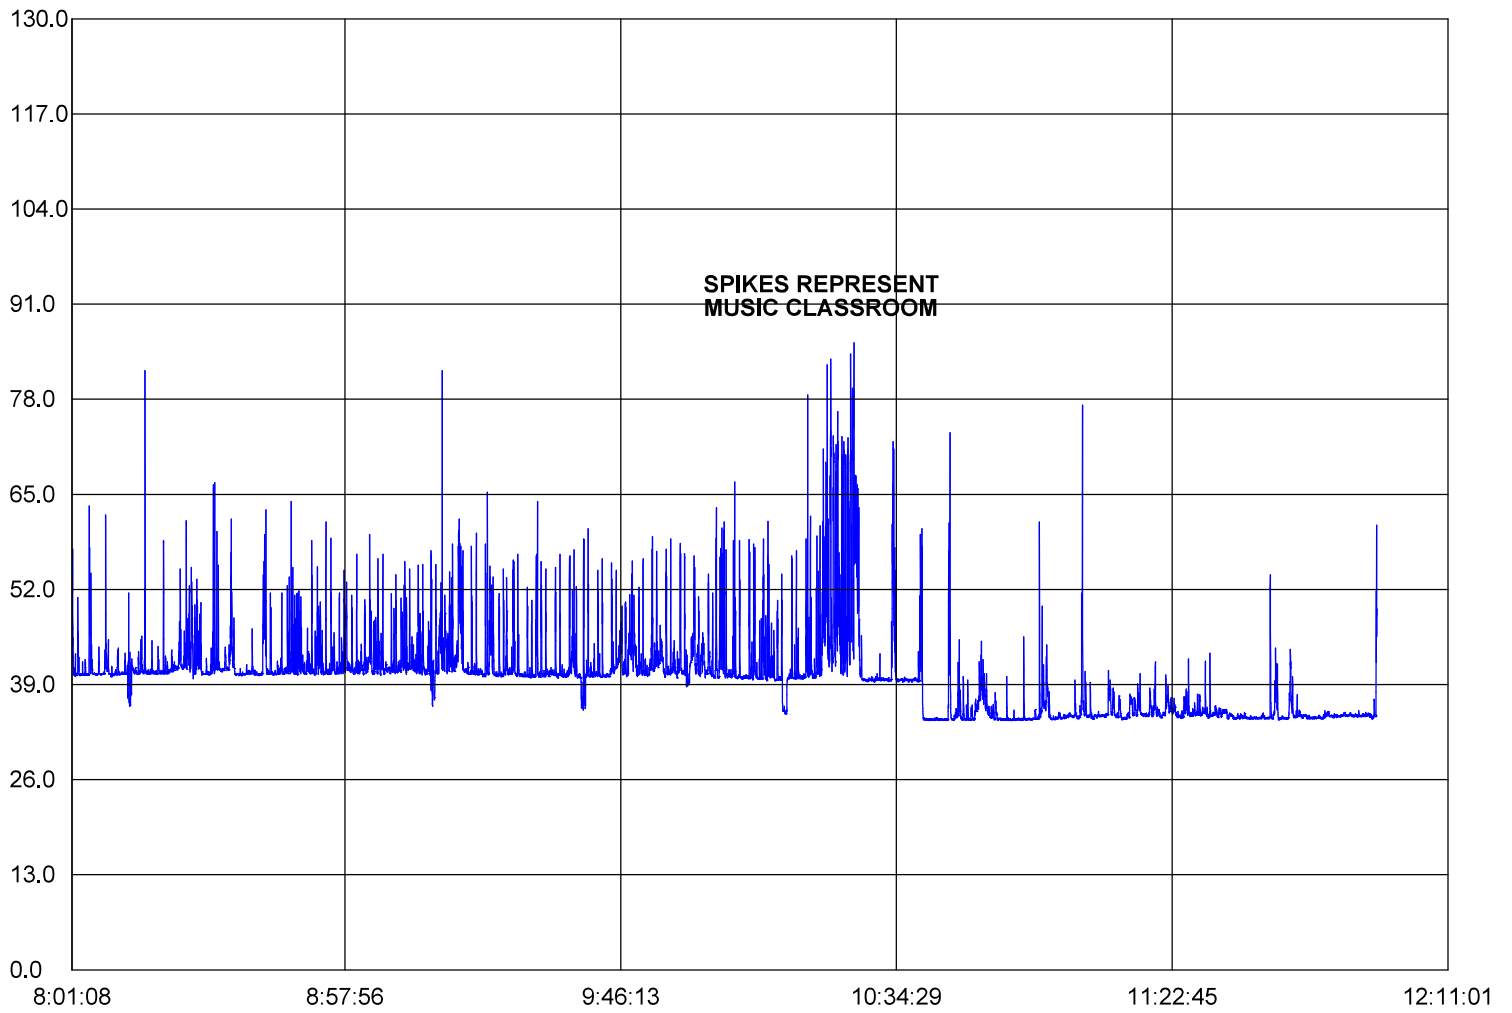
BASEMENT HALLWAY 1

Standard Sound Level Meter RealTime Graph
Time: 2019-10-18 14:47:36

Start Time: 18-10-2019,8:01:08
Maxnum: 85.70 18-10-2019,10:27:03
Minnum: 34.10 18-10-2019,10:40:01
Sample Rate: 1.00
Average: 39.98

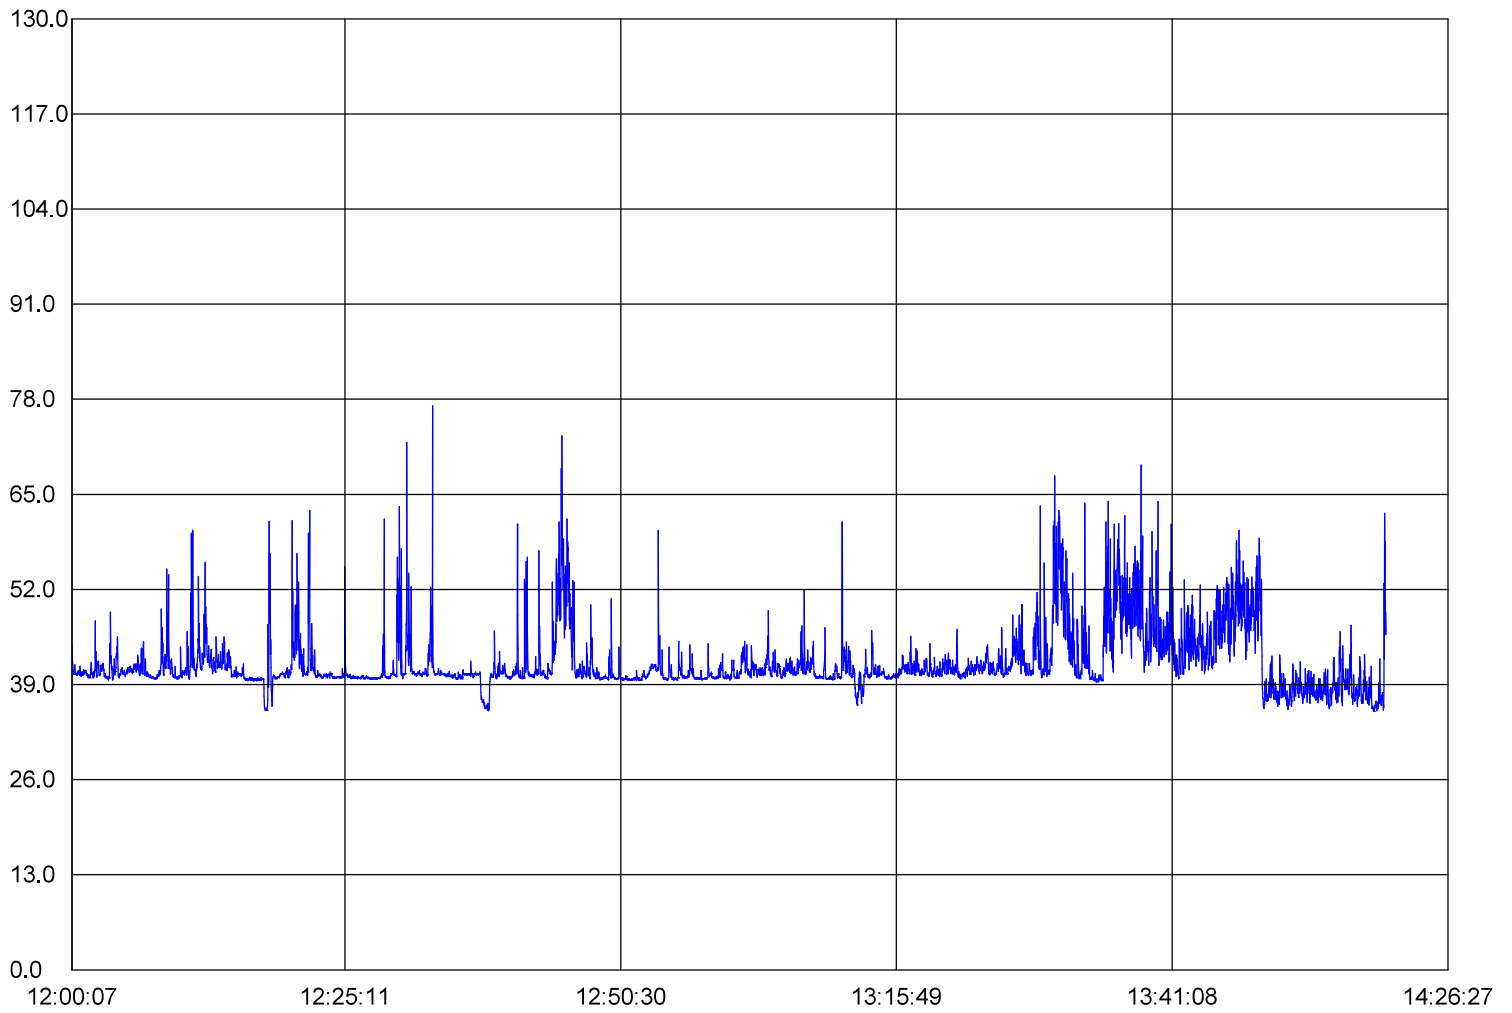
BASEMENT HALLWAY 2

Standard Sound Level Meter RealTime Graph
Time: 2019-10-18 14:47:49

Start Time: 18-10-2019,12:00:07
Maxnum: 77.10 18-10-2019,12:33:14
Minnum: 35.30 18-10-2019,13:59:40
Sample Rate: 1.00
Average: 41.89

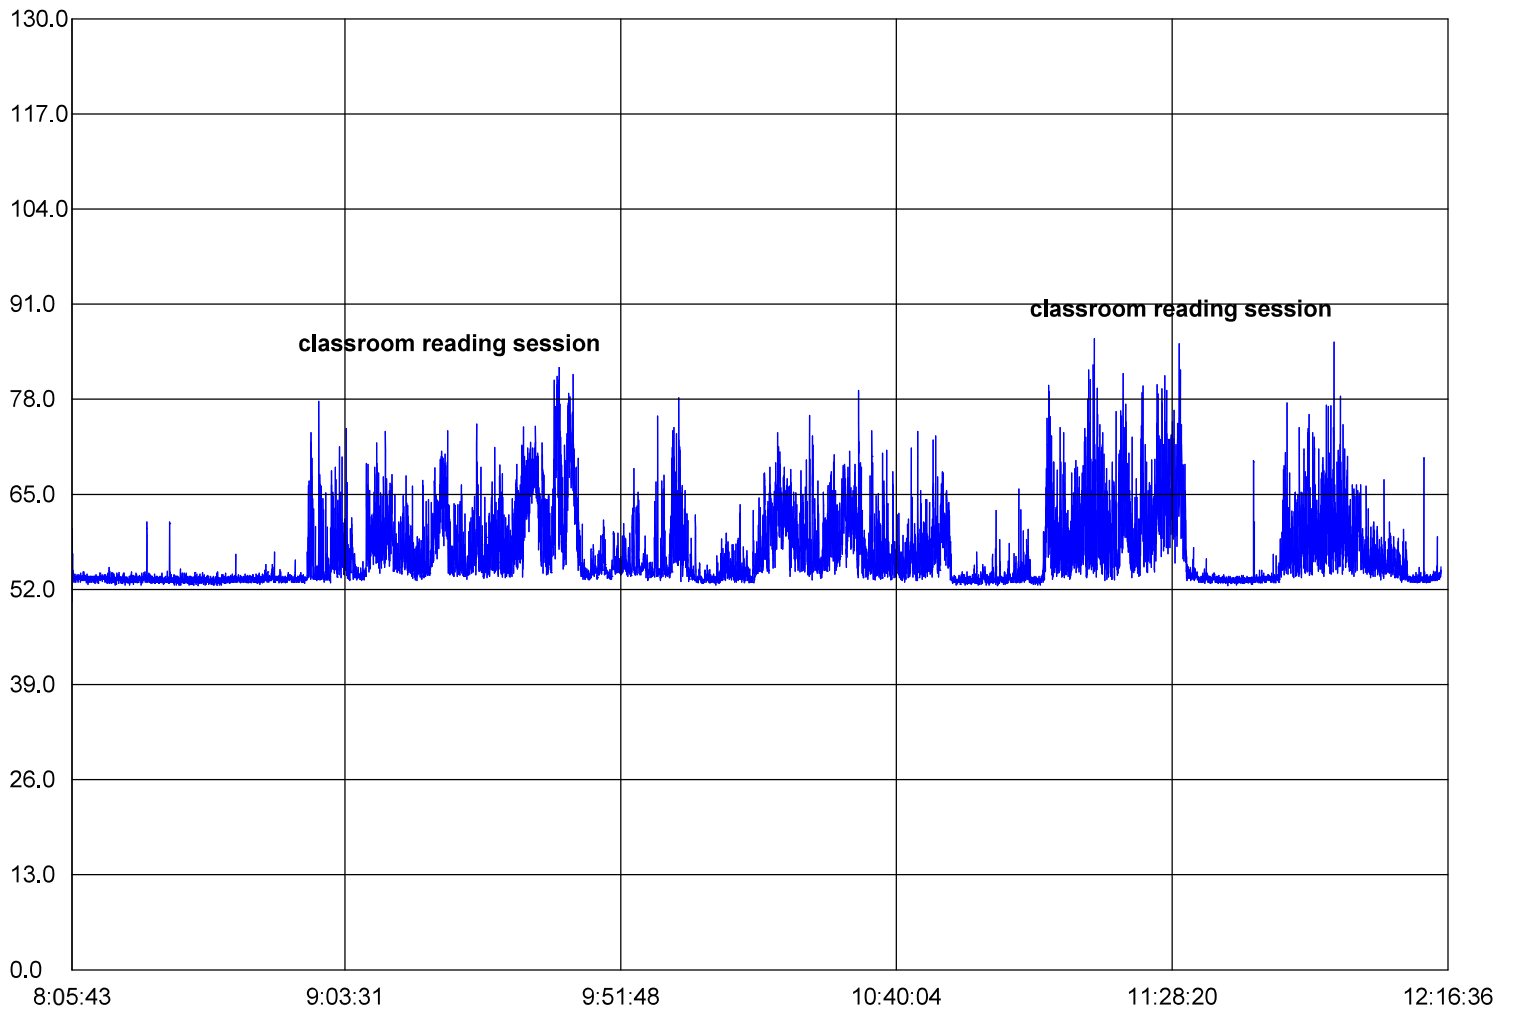
LIBRARY 1

Standard Sound Level Meter RealTime Graph
Time: 2019-10-18 14:52:11

Start Time: 18-10-2019,8:05:43
Maxnum: 86.30 18-10-2019,11:14:42
Minnum: 50.30 18-10-2019,8:15:43
Sample Rate: 1.00
Average: 56.90

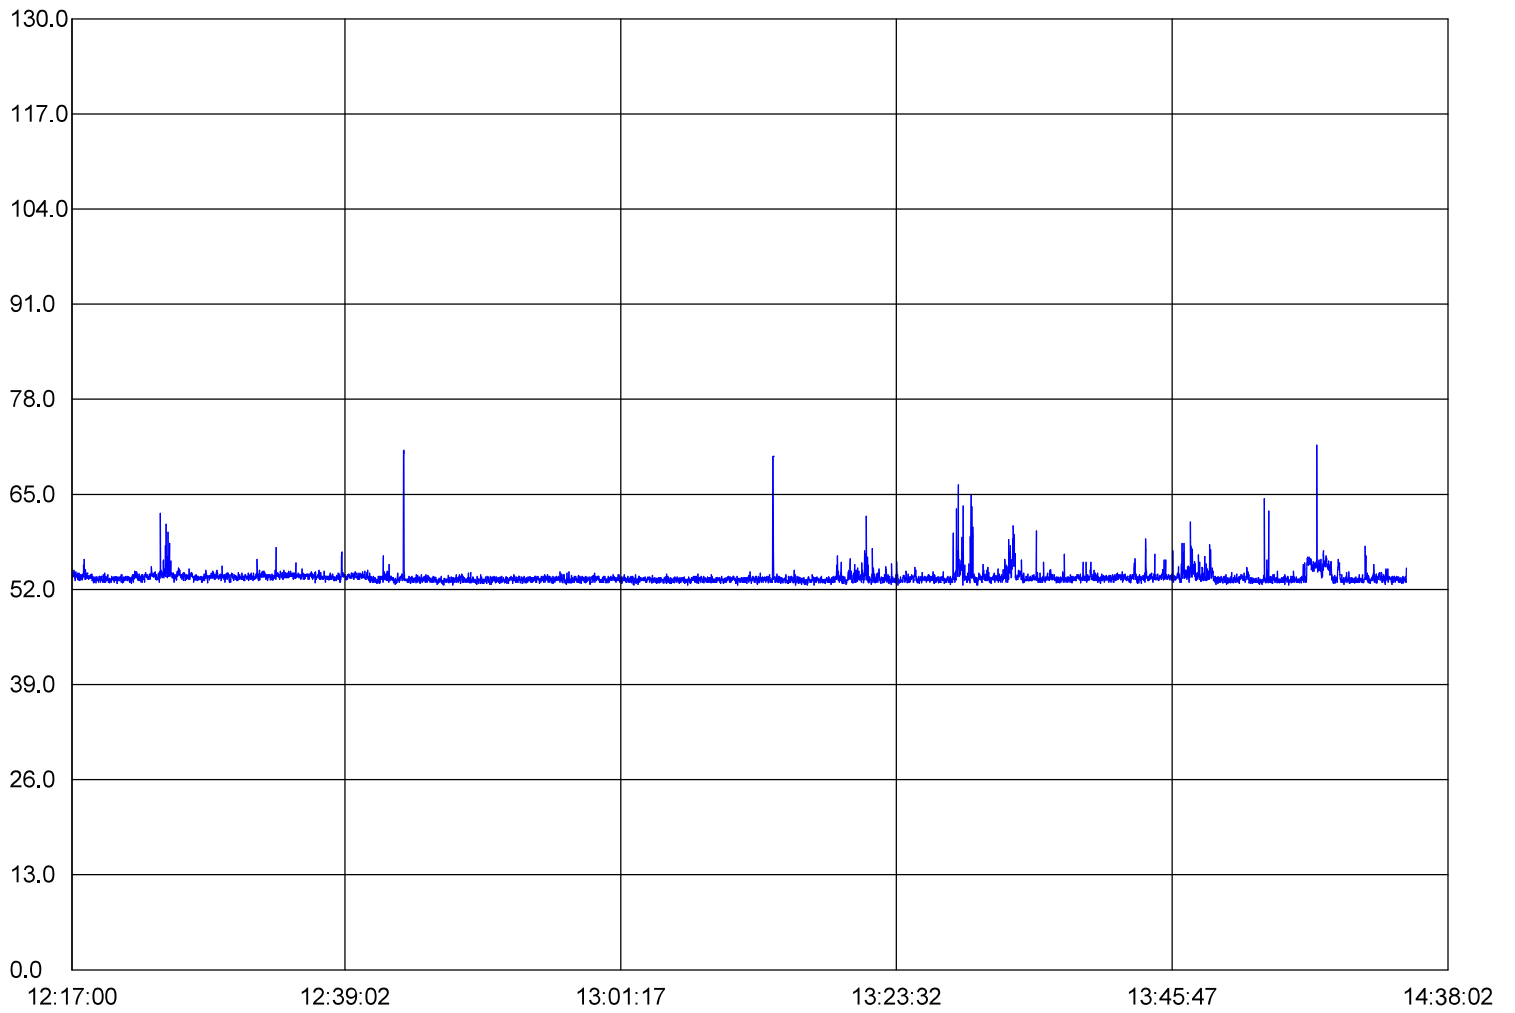
LIBRARY 2

Standard Sound Level Meter RealTime Graph
Time: 2019-10-18 14:52:27

Start Time: 18-10-2019,12:17:00
Maxnum: 71.70 18-10-2019,13:57:28
Minnum: 52.60 18-10-2019,12:47:01
Sample Rate: 1.00
Average: 53.64
