| Project: <b>Greenacres School</b> | Date: <b>10/24/19</b> |

| Inspection Type: <b>Noise and Dust Monitoring</b> | Contractor: <b>Park East</b> |

## INSPECTION REPORT

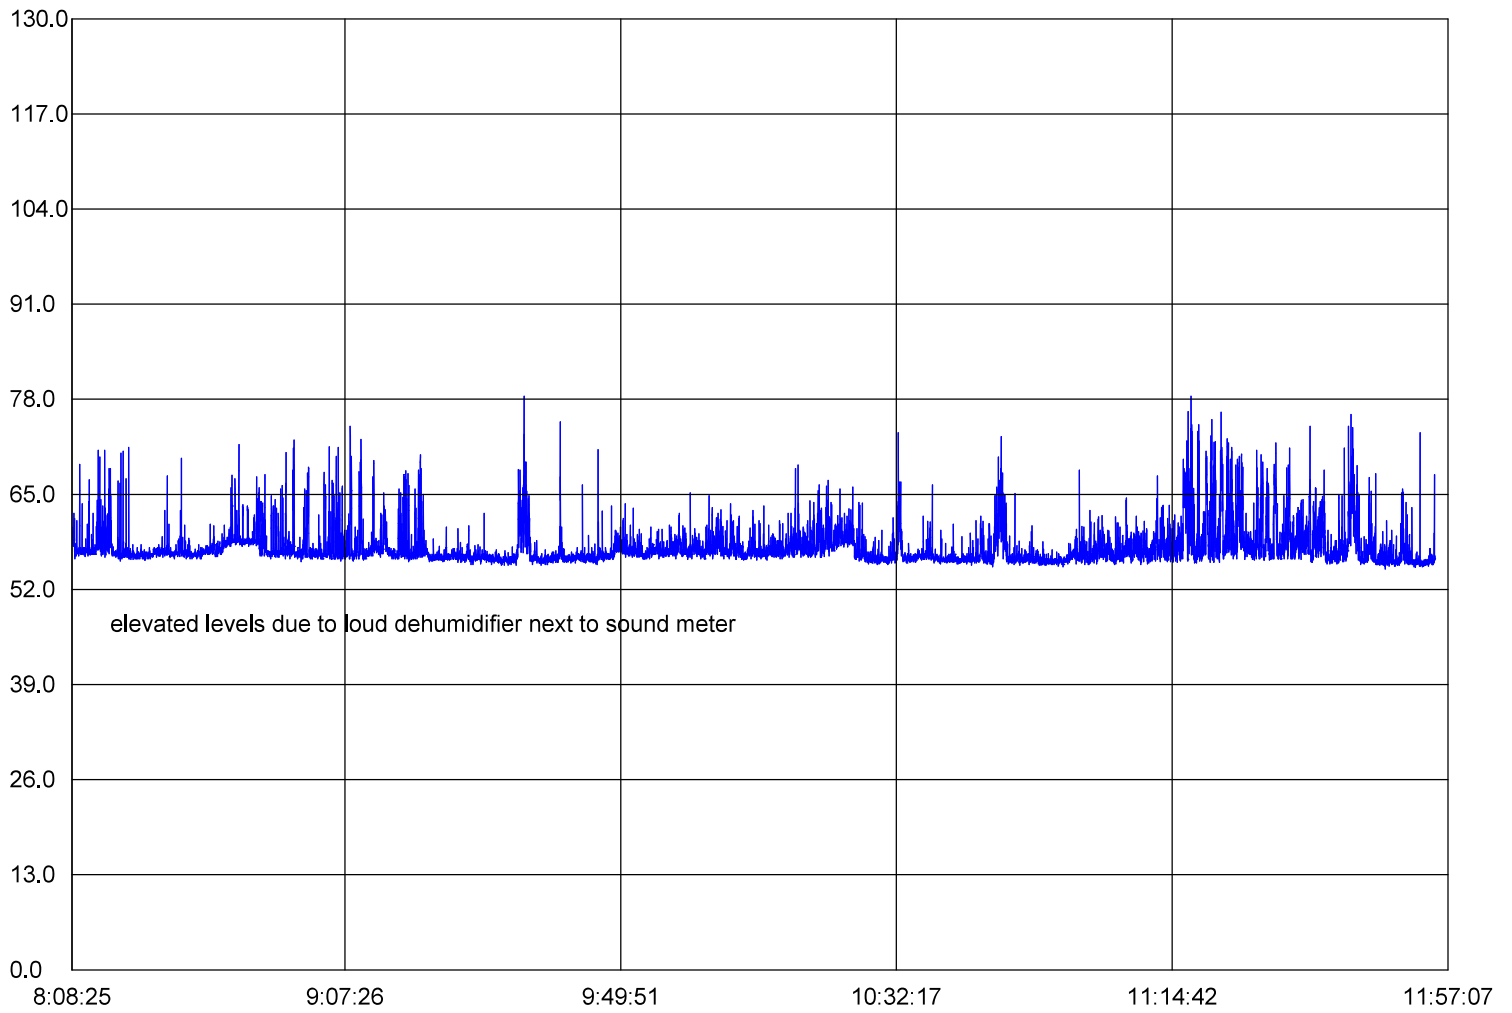
Standard Sound Level Meter RealTime Graph  
Time: 2019-10-24 14:46:51

Noise caused by ongoing construction in the perimeter of the school was monitored using a sound level meter. Readings were taken in the basement hallway (20 feet from construction), next to the work performed today.

An Average noise level of 57.60 dB was measured for the day

Start Time: 24-10-2019,8:08:25  
Maxnum: 78.40 24-10-2019,9:35:00  
Minnum: 54.80 24-10-2019,11:47:29  
Sample Rate: 1.00  
Average: 57.79

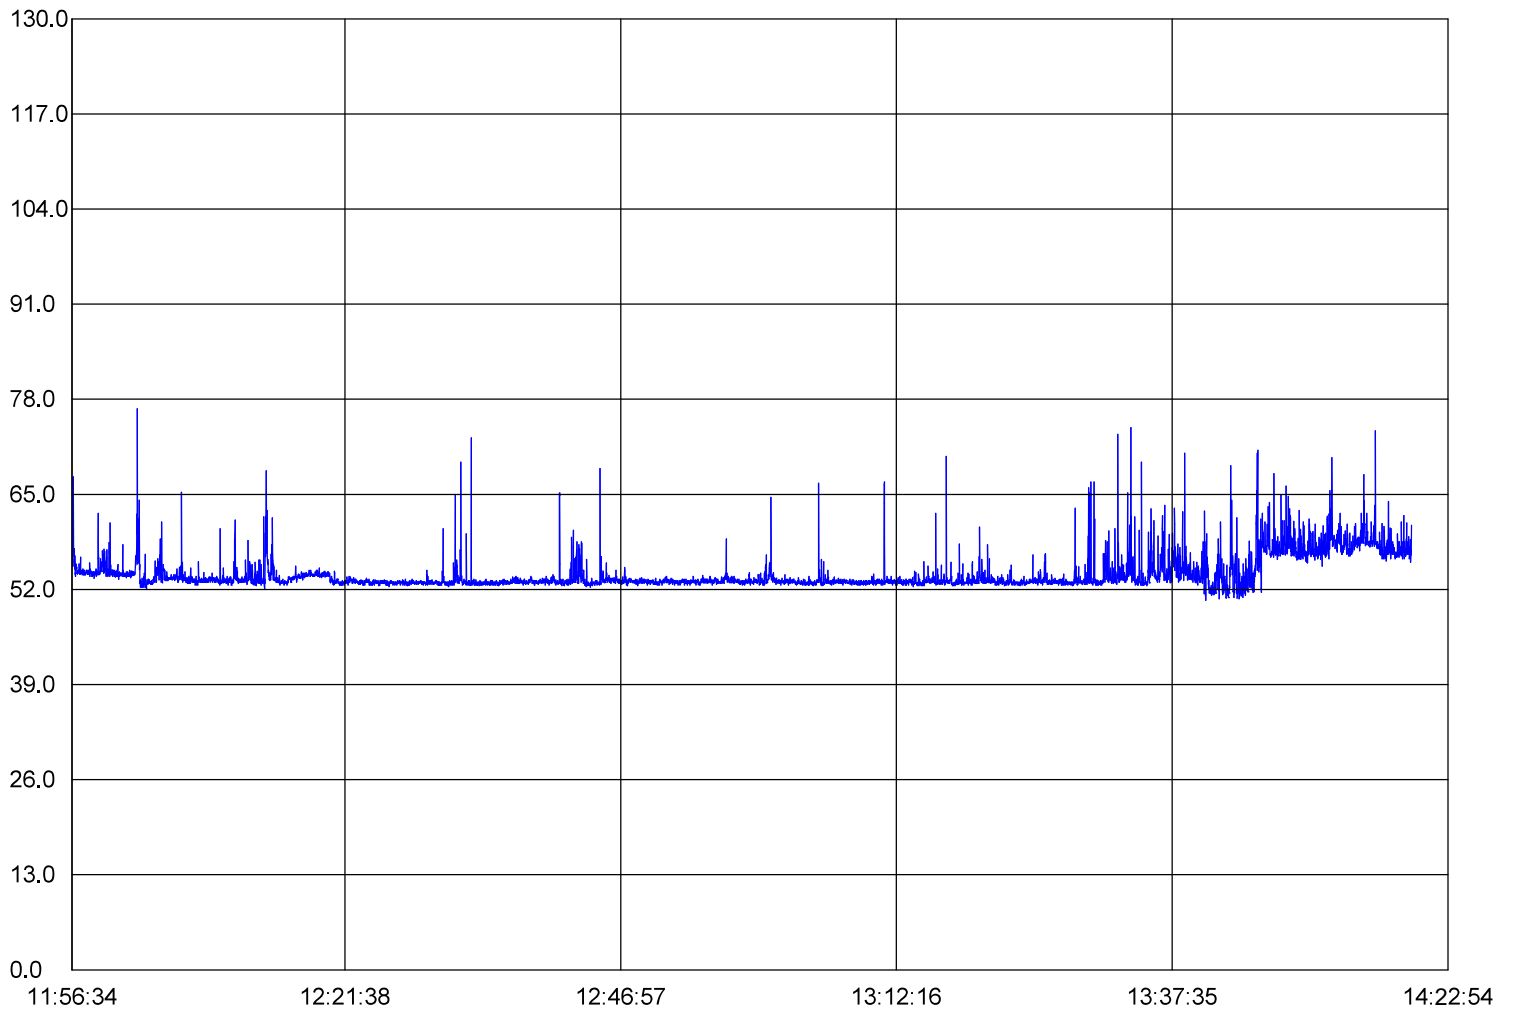
Standard Sound Level Meter RealTime Graph  
Time: 2019-10-24 14:47:1

Start Time: 24-10-2019,11:56:34  
Maxnum: 76.70 24-10-2019,12:02:35  
Minnum: 50.50 24-10-2019,13:40:41  
Sample Rate: 1.00  
Average: 54.03

BASEMENT HALLWAY 2
