## INSPECTION REPORT

| Project: <b>Greenacres School</b> | Date: <b>11/14/19</b> |

| Inspection Type: <b>Noise and Dust Monitoring</b> | Contractor: <b>Park East</b> |

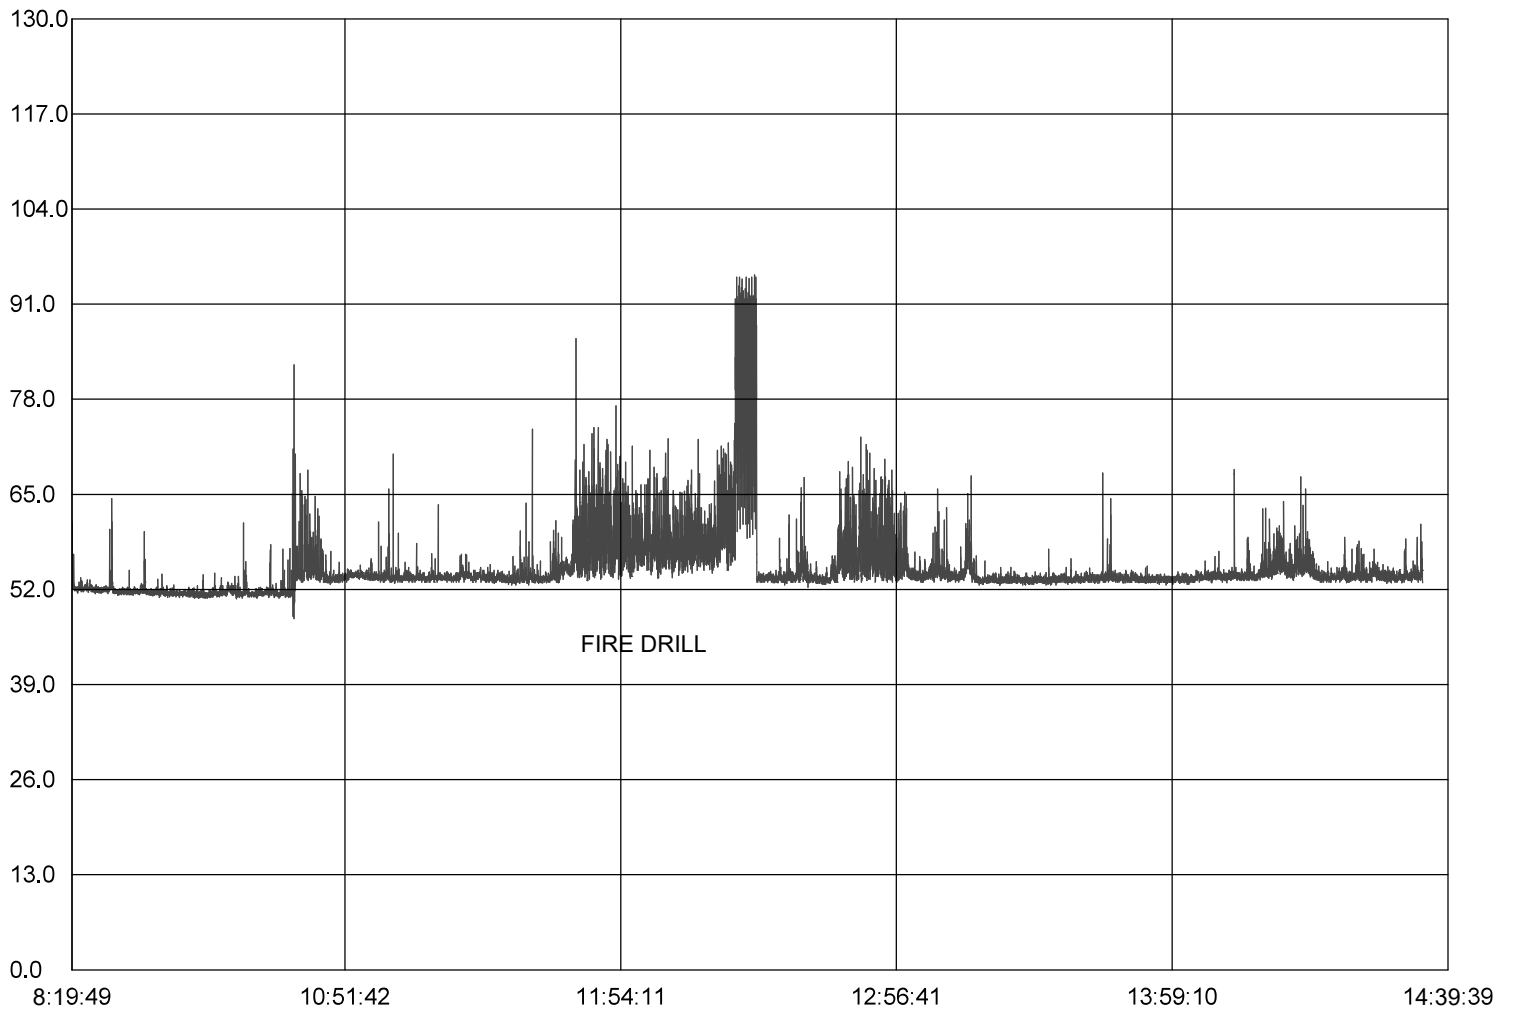
LIBRARY

Standard Sound Level Meter RealTime Graph  
Time: 2019-11-14 14:58:51

Start Time: 14-11-2019,8:19:49  
Maxnum: 95.00 14-11-2019,12:24:33  
Minnum: 48.00 14-11-2019,10:40:09  
Sample Rate: 1.00  
Average: 54.79

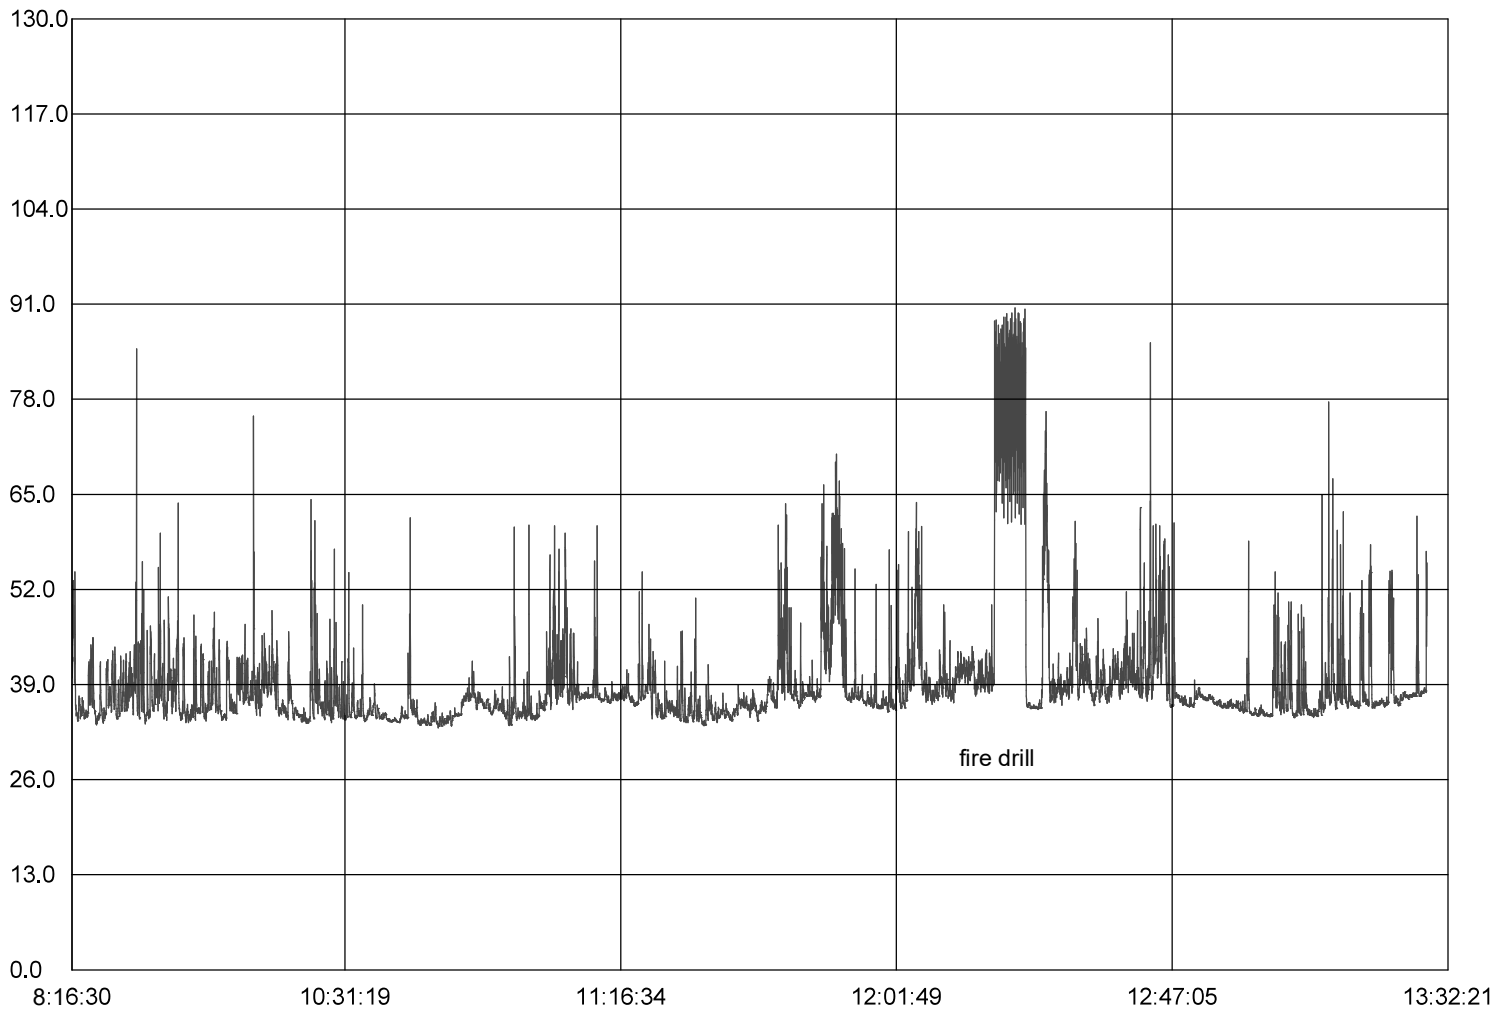
BASEMENT HALLWAY 1

Standard Sound Level Meter RealTime Graph  
Time: 2019-11-14 14:55:30

Start Time: 14-11-2019,8:16:30  
Maxnum: 90.50 14-11-2019,12:21:17  
Minnum: 33.10 14-11-2019,10:46:38  
Sample Rate: 1.00  
Average: 39.05

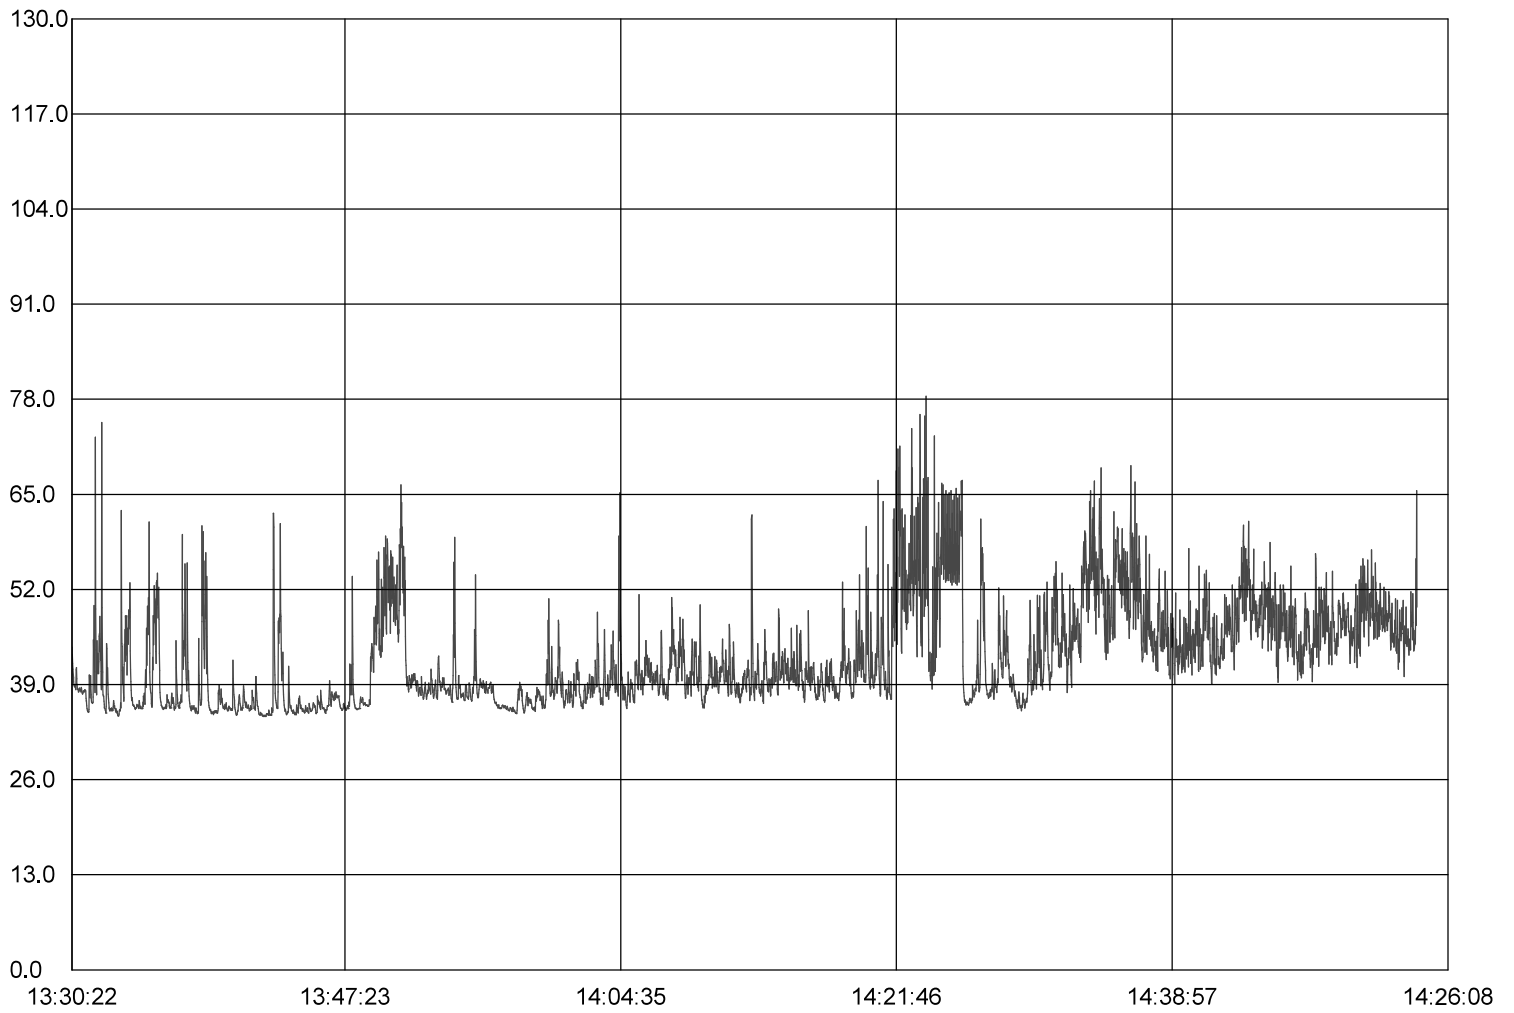
BASEMENT HALLWAY 2

Standard Sound Level Meter RealTime Graph  
Time: 2019-11-14 14:59:42

Start Time: 14-11-2019,13:30:22  
Maxnum: 78.40 14-11-2019,14:23:37  
Minnum: 34.60 14-11-2019,13:42:18  
Sample Rate: 1.00  
Average: 42.65
