INSPECTION REPORT

REPORT #
62

Project: Greenacres	Date: 12/02/2019
Address: 41 Huntington Avenue, Scarsdale NY 10583	Job ID / MU #:
Client: Park East Construction	Weather: Snow

Inspection Type: Noise and Dust Monitoring	Contractor: Park East
Present At Site: 7:00 AM	Sub-Contractor:
General Area: Northern Yard of School	CM/Designer:
Specific Location: Northern side of School 1st, 2nd floor, and basement	
Last Inspection:	Building Code Section:
Reviewed Approved	Drawings:
	Submittals
	Other:

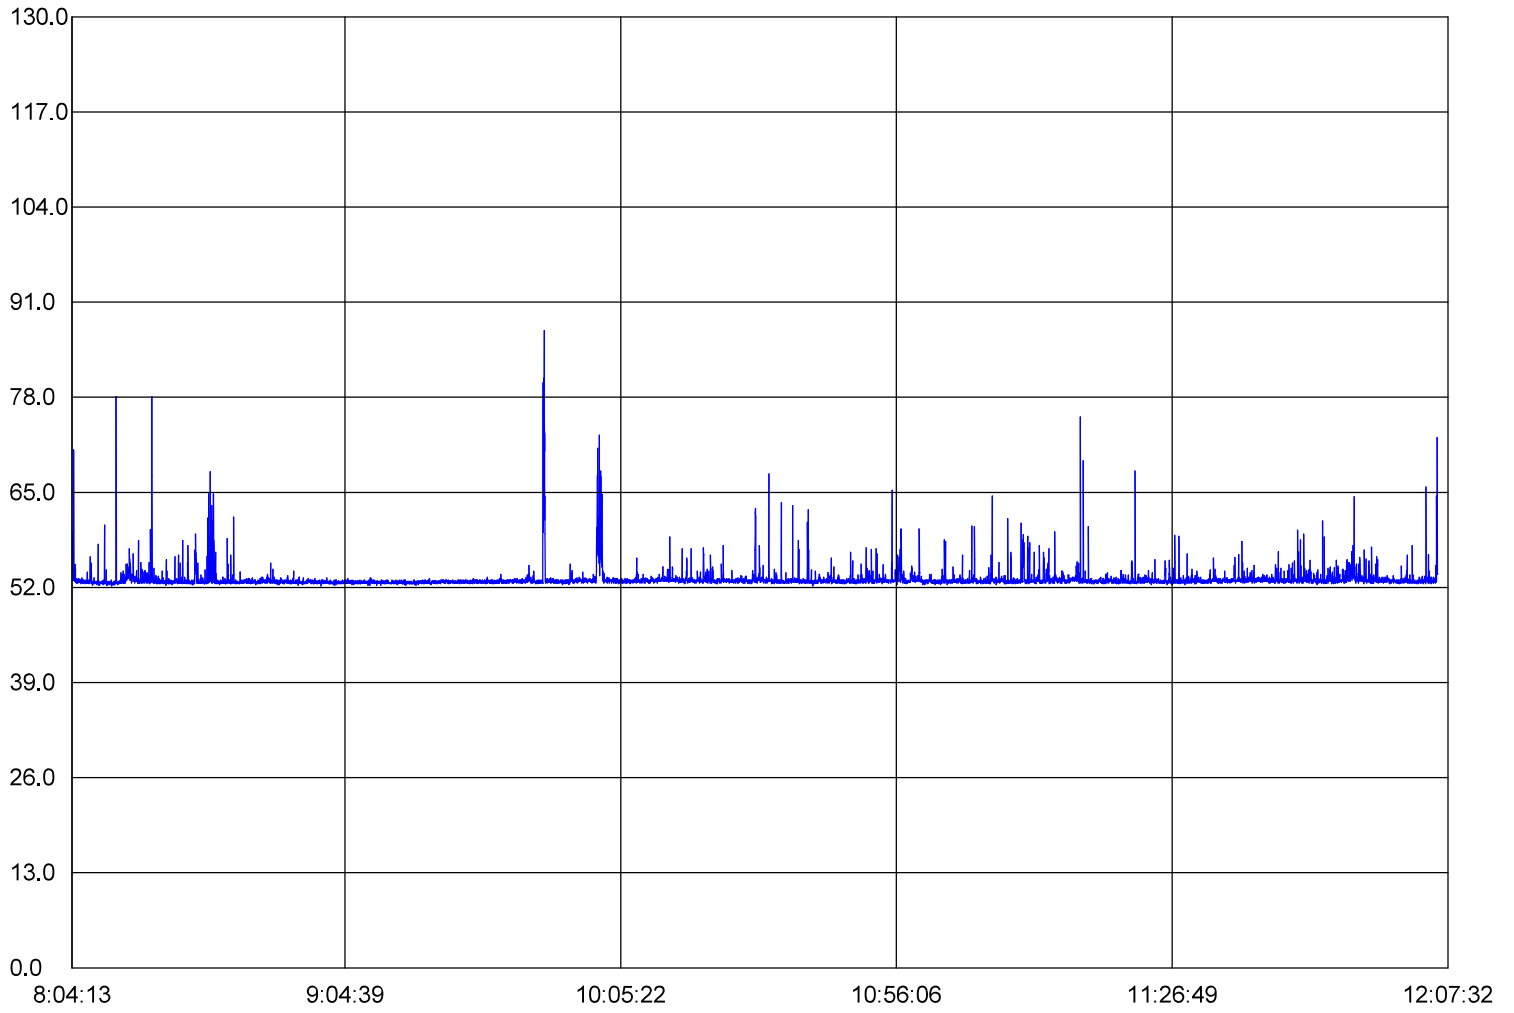
BASEMENT HALLWAY

Standard Sound Level Meter RealTime Graph
Time: 2019-12-2 12:28:46

Start Time: 02-12-2019,8:04:13
Maxnum: 87.10 02-12-2019,10:16:51
Minnum: 52.20 02-12-2019,9:28:39
Sample Rate: 1.00
Average: 53.12

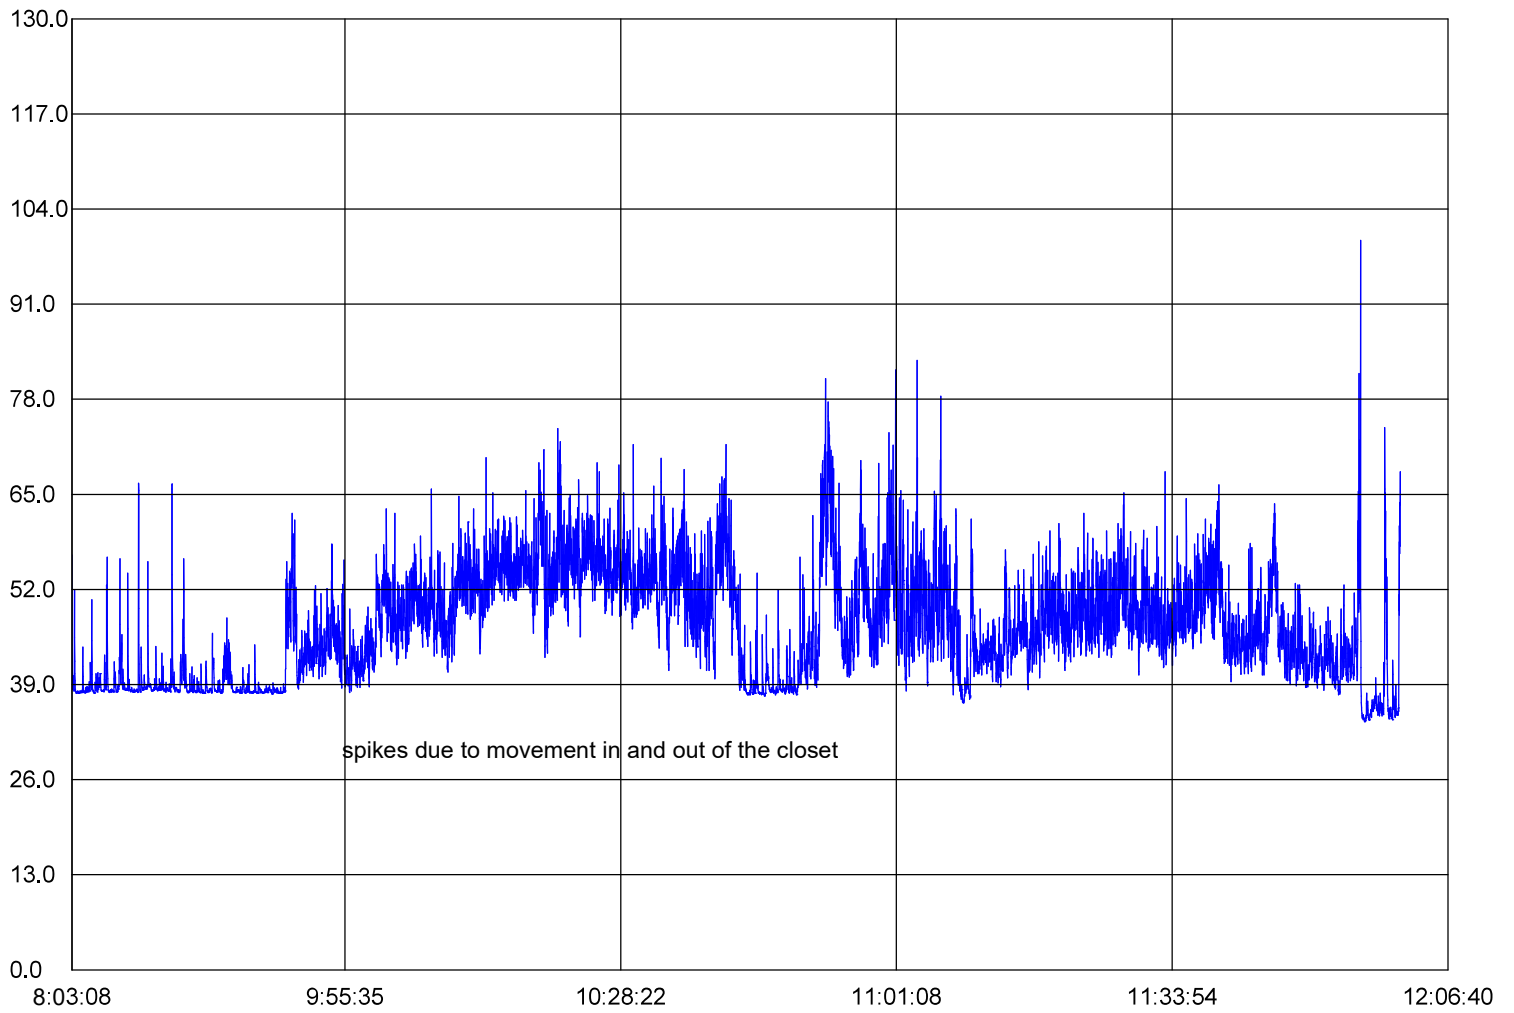
2nd floor storage

Standard Sound Level Meter RealTime Graph
Time: 2019-12-2 12:26:11

Start Time: 02-12-2019,8:03:08
Maxnum: 99.70 02-12-2019,11:56:18
Minnum: 33.90 02-12-2019,11:56:47
Sample Rate: 1.00
Average: 46.90
