INSPECTION REPORT

REPORT #
63

Project: Greenacres elementary School	Date: 12/03/2019
Address: 41 Huntington Avenue, Scarsdale NY	Job ID / MU #:
Client: Park East Construction	Weather: Sunny

Inspection Type: Noise and Dust Monitori	Contractor: Park East
Present At Site: 7:00AM	Sub-Contractor:
General Area: Northern Yard of School	CM/Designer:
Specific Location:	
Last Inspection: North Side of school Base, 1st, 2nd floor	Building Code Section:
Reviewed Approved	Drawings:
	Submittals
	Other:

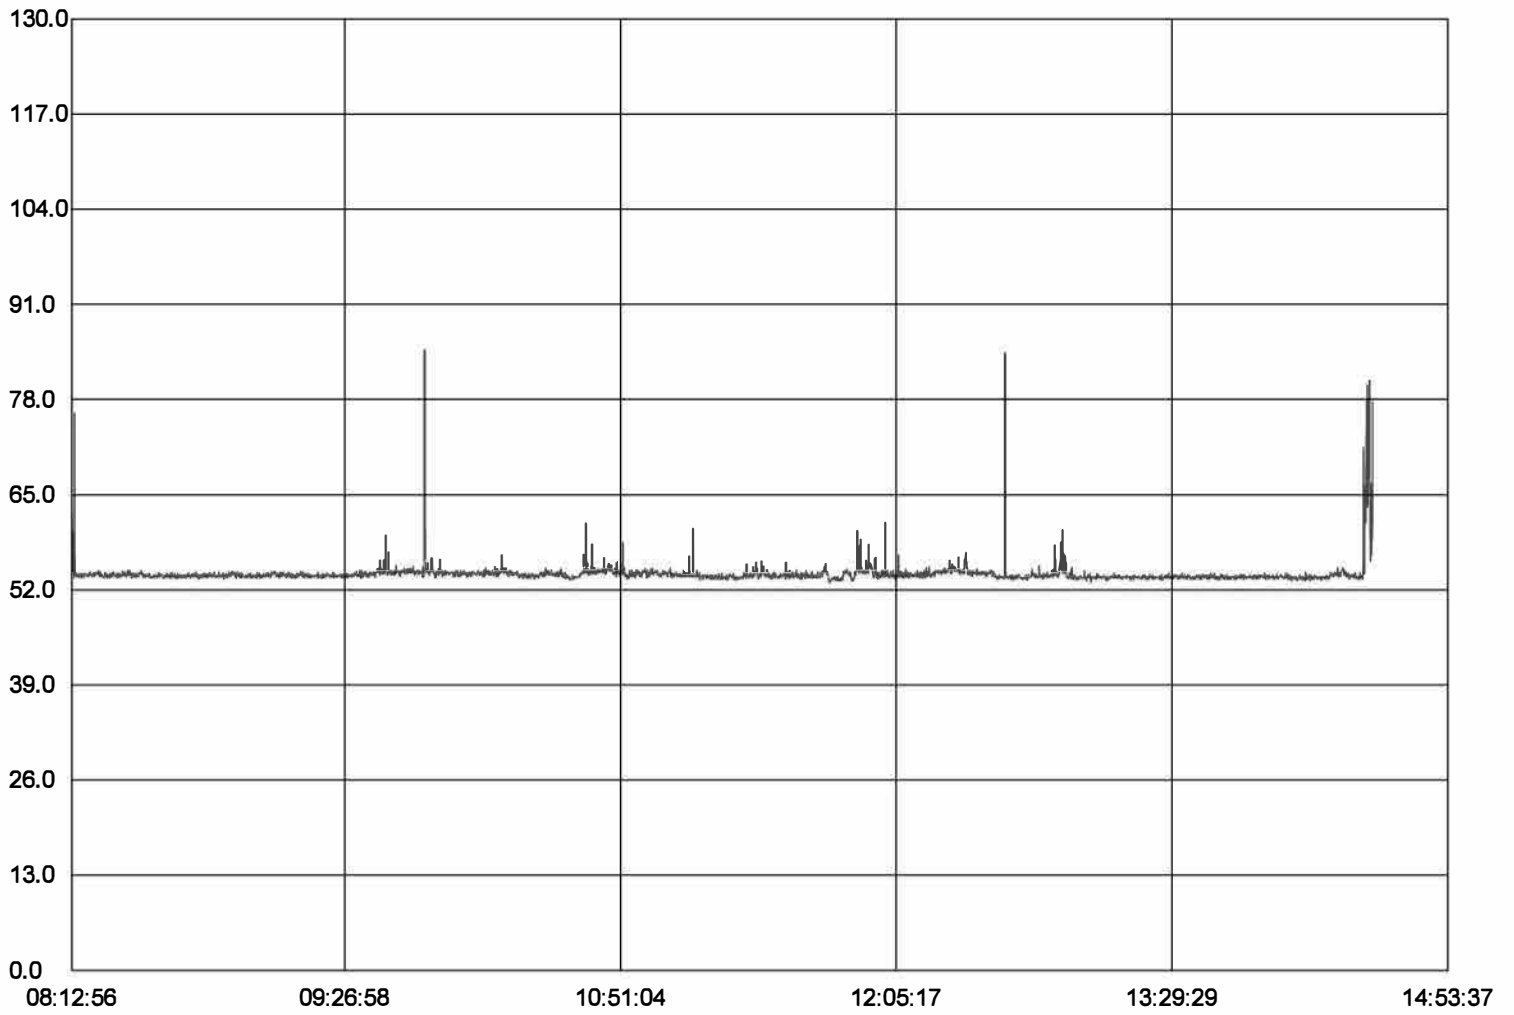
BASEMENT HALLWAY

Standard Sound Level Meter RealTime Graph
Time: 2019-12-03 14:59:40

Start Time: 03-12-2019,08:12:56
Maxnum: 83.12 03-12-2019,11:41:29
Minnum: 53.41 03-12-2019,10:05:07
Sample Rate: 1.00
Average: 51.22

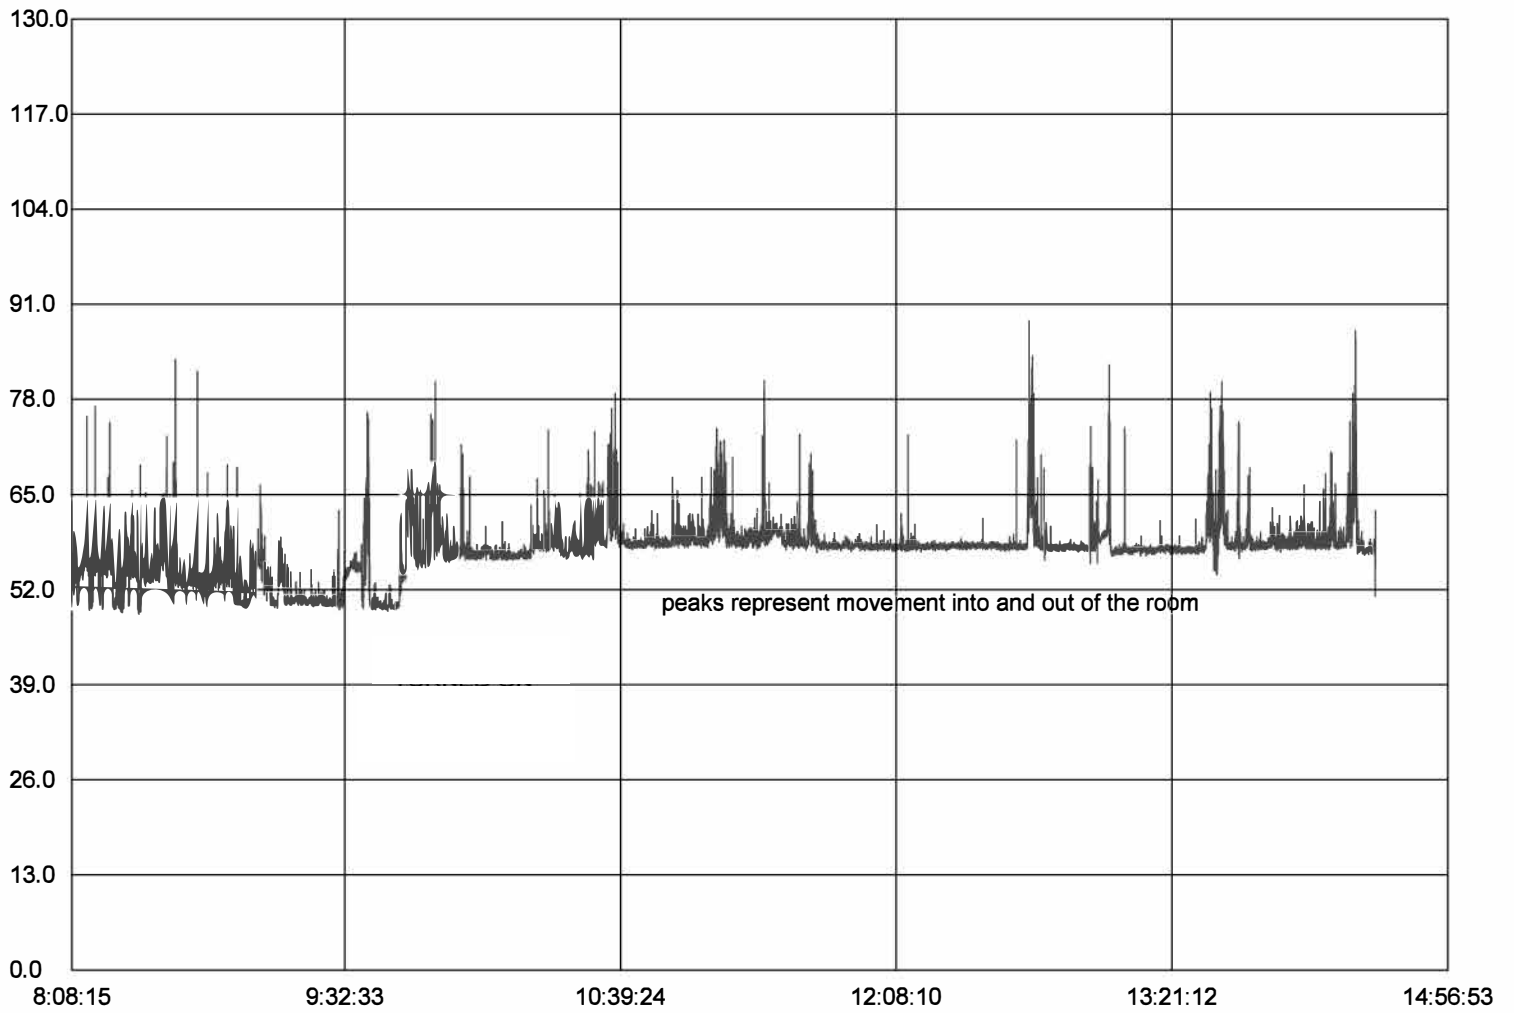
2ND FLOOR STORAGE UNIT

Standard Sound Level Meter RealTime Graph
Time: 2019-12-03 14:57:10

Start Time: 03-12-2019,08:08:15

Maxnum: 83.02 03-12-2019,11:24:19

Minnum: 53.13 03-12-2019,10:01:27

Average: 52.13
