INSPECTION REPORT

REPORT #	
64

Project: GF	REENACRES ELEMENTARY SCHOOL	Date: 1	2/05/2019						
Address: 41 HUNTINGTON AVENUE, SCARSDALE NY 10583			Job ID / MU #:						
Client: PARK EAST CONSTRUCTION			Weather: CLOUDY						
Inspection '	Гуре: NOISE AND DUST MONITORING	Contractor:	PARK I	FAST					
	Site: 7:00AM	Sub-Contractor:							
General Are		CM/Designer:							
Specific Location: NORTHERN SIDE OF SCHOOL BASEMENT, 1ST, 2ND FLOOR									
Last Inspec		Building Code Section:

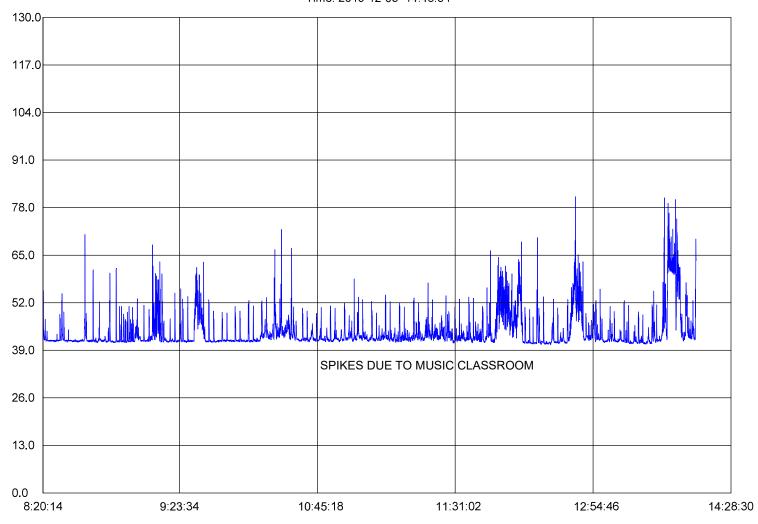
BASEMENT HALLWAY

Standard Sound Level Meter RealTime Graph Time: 2019-12-05 14:48:54

Start Time:
 05-12-2019,8:20:14

Maxnum:
 81.00
 15-10-2019,9:51:46

Minnum:
 40.50
 15-10-2019,9:47:29

Sample Rate: 1.00 Average: 49.98

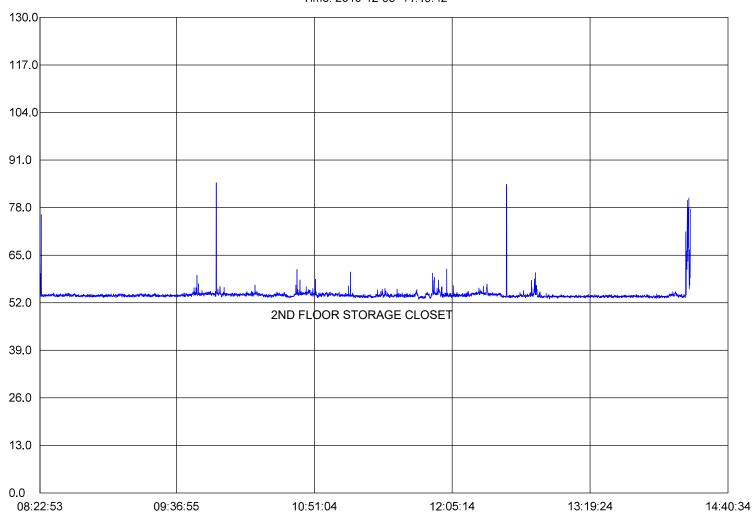
Standard Sound Level Meter RealTime Graph Time: 2019-12-05 14:49:42

Start Time:
 05-12-2019,08:22:53

Maxnum:
 82.71
 15-10-2019,12:40:59

Minnum:
 52.02
 15-10-2019,13:01:47

Sample Rate: 1.00 Average: 52.31
