INSPECTION REPORT

Project: GREENACRES ELEMENTARY SCHOOL							Date: 02/10/2020				
Address: 41 HUNTINGTON AVENUE, SCARS						NY	Job ID / MU #:				
Client: PARK EAST CONSTRUCTION							Weather: R	RAIN			
Inspection Type: Noise and Dust Monitor						Contractor:					
Present At Site:					Sub-Contractor:						
General Area:					CM/Designer:						
Specific Location: N and S Basement, 1st floor, 2nd floor											
Last Inspection:					Building Code Section:						
Reviewed	Drawing	s:			N u						
	Submitta	als									
Approved	Other:	Other:									
Deficiency:					Resoluti	on:					
Request For Information: Non-Conformance Report:											
T ₁ =	1			NCD #	1	NGD #	D 1 1	NGD #			
RFI # :	Issued	RFI # :	Answered	NCR # :	Issued	NCR # : [Resolved	NCR # : Open

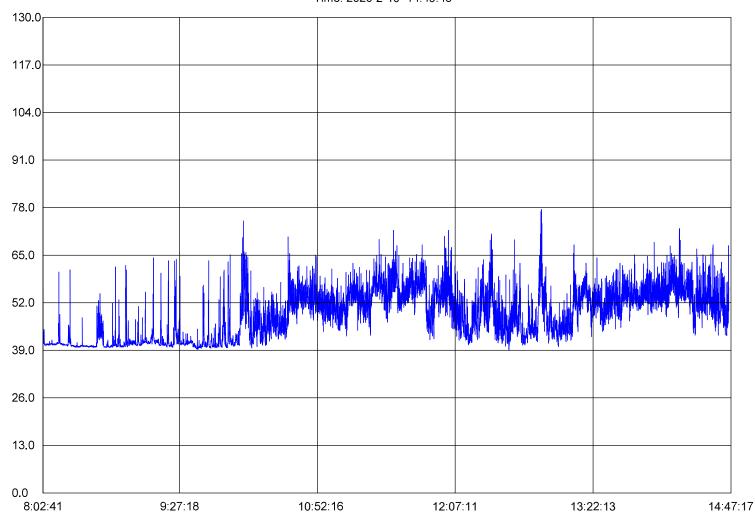
Standard Sound Level Meter RealTime Graph Time: 2020-2-10 14:49:45

-	700			•	•	2.1	1 1				
Noise caused by ongoing construction in the perimeter of the school was monitored using											
a sound level meter. Readings were taken in the basement hallway 20 feet from											
construc	tion) ne	ext to the v	vork perfor	rmed today	√.						
An avera	age nois	se level of	49.59 db v	vas measu	red for 1	the day.

Start Time: 10-02-2020,8:02:41

Maxnum: 75.10 10-02-2020,10:03:08 Minnum: 39.40 10-02-2020,10:41:52

Sample Rate: 1.00 Average: 49.59
