**INSPECTION REPORT**

Project: GREENACRES ELEMENTARY SCHOOL			Date: 02.24.2020					
Address: 41 HUNTINGTON AVENUE, SCARSDALE NY			Job ID / MU #:					
Client: PARK EAST CONSTRUCTION			Weather: SUNNY					
Inspection Type: NOISE AND DUST MONITOR Contractor:								
Present At		Sub-Contractor:						
General Are	ea:	CM/Designer:						
Specific Loc	cation: N AND S BASEMENT, 1ST FI	LOOR, 2ND FI	LOOR					
Last Inspec	tion:	Building Code Sec	ction:					
Reviewed	Drawings:	A						
Approved	Submittals	Submittals						
npproved	Other:							
Deficiency:		Resolution:						
Request Fo	r Information:							
Non-Confor	rmance Report:							
RFI # :	Issued RFI # : Answered NCR # :	Issued NCR #	: Resolved	NCR # : Open				
Observatio	ns/Notes:	<u>.</u>						
Noise caused by ongoing construction in the perimeter of the school was monitored using a sound level meter. Readings were taken in the basement hallway (20 feet from construction) next to the work performed today. An average noise level of 58.2 db was measured for the day.

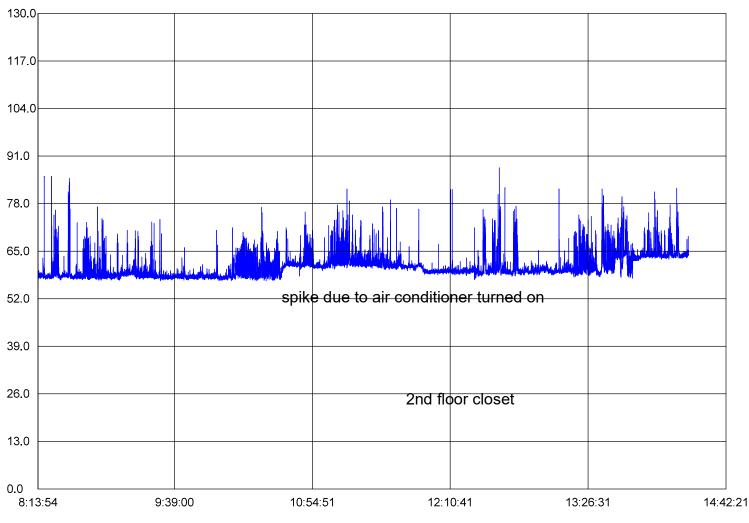
Standard Sound Level Meter RealTime Graph Time: 2020-2-24 14:52:10

Start Time:
 24-02-2020,8:13:54

Maxnum:
 87.80
 24-02-2020,12:37:43

Minnum:
 54.90
 24-02-2020,8:23:54

Sample Rate:
 1.00

Average:
 58.71

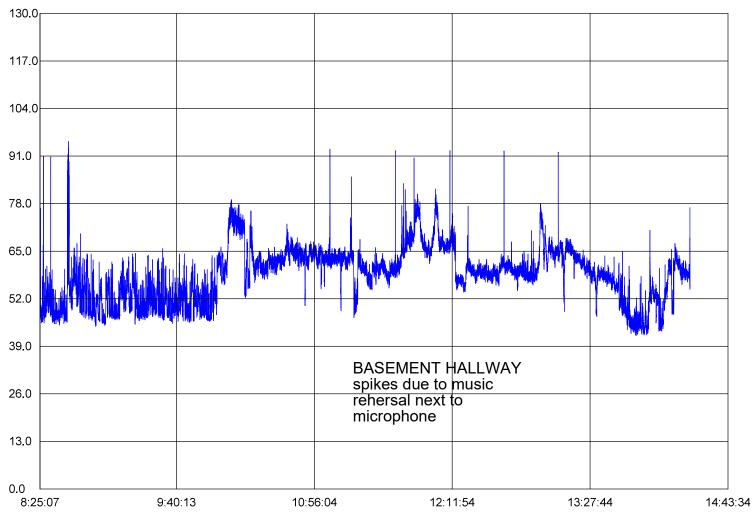
Standard Sound Level Meter RealTime Graph Time: 2020-2-24 14:49:19

Start Time:
 24-02-2020,8:25:07

Maxnum:
 95.00
 24-02-2020,8:40:57

Minnum:
 41.90
 24-02-2020,13:53:07

Sample Rate:
 1.00

Average:
 58.27
