INSPECTION REPORT	
DoB Special Inspection Agency #0230	44
	I IVELOIVI #

Project: Greenacres School						Date: 11/	01/19		
Address: 41 Huntington Avenue, Scarsdale NY 10583						Job ID/ MU#:			
Client: Park East Construction						Weather: Cloudy			
Inspection '	Tyne Ni	' 1D	/ N.f '/		Contract	or: Park E	Enst		
Procent At	Site: 7:	oise and D	ust Monito	oring	Sub-Con		zasi

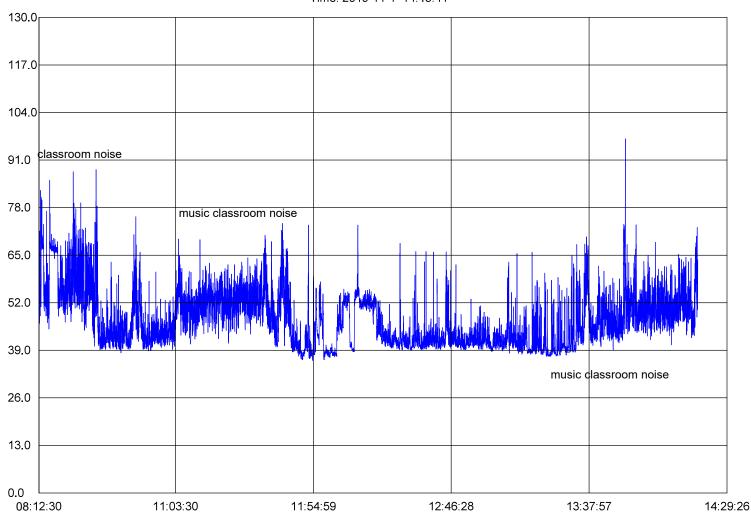
Standard Sound Level Meter RealTime Graph Time: 2019-11-1 14:43:41

-	
Noise	caused b	y ongoing o	construction	in the perim	neter of th	ne school w	vas monitore	ed using a sound	
level 1	meter. Re	adings were	e taken in th	e basement l	hallway ((20 feet fro	m constructi	ion), next to the	
work	performe	d today.							
An Av	verage no	oise level of	47.37 dB w	as measured	I for the o	lay			
Dust I	Levels w	thin the Per	rimeter of th	e school we	re measu	red. These	Readings ca	n be found in	
the ch	art on the	e next page.	Daily PM2.	5 density =	1.5, PM1	0 density =	= 3.9		
Work	today in	cluded: Exc	avating dirt	(CAT360), l	Delivery	of 3" stone	es, removal c	of soil/forms	
	·		C	, ,,,	•		,		
Attachment	s/Photos								
Time on sit		0 AM		Т	ime off si	te: 3:30 P	M		
nspected W	ork Satisf	actory (Excep	ot As Noted):			spection Req		Work Completed:	
_					/11/-	£ -			
nspector: E	raid Hys	aj —	Signa	iture:	All I	7	Certification:

Start Time: 01-11-2019,08:12:30 Maxnum: 96.80 01-11-2019,13:51:30 Minnum: 36.20 01-11-2019,11:54:45

Sample Rate: 1.00 Average: 47.37
