# INSPECTION REPORT

| Project: <b>Greenacres School</b> | Date: <b>11/21/19</b> |

| Inspection Type: <b>Noise and Dust Monitoring</b> | Contractor: <b>Park East</b> |

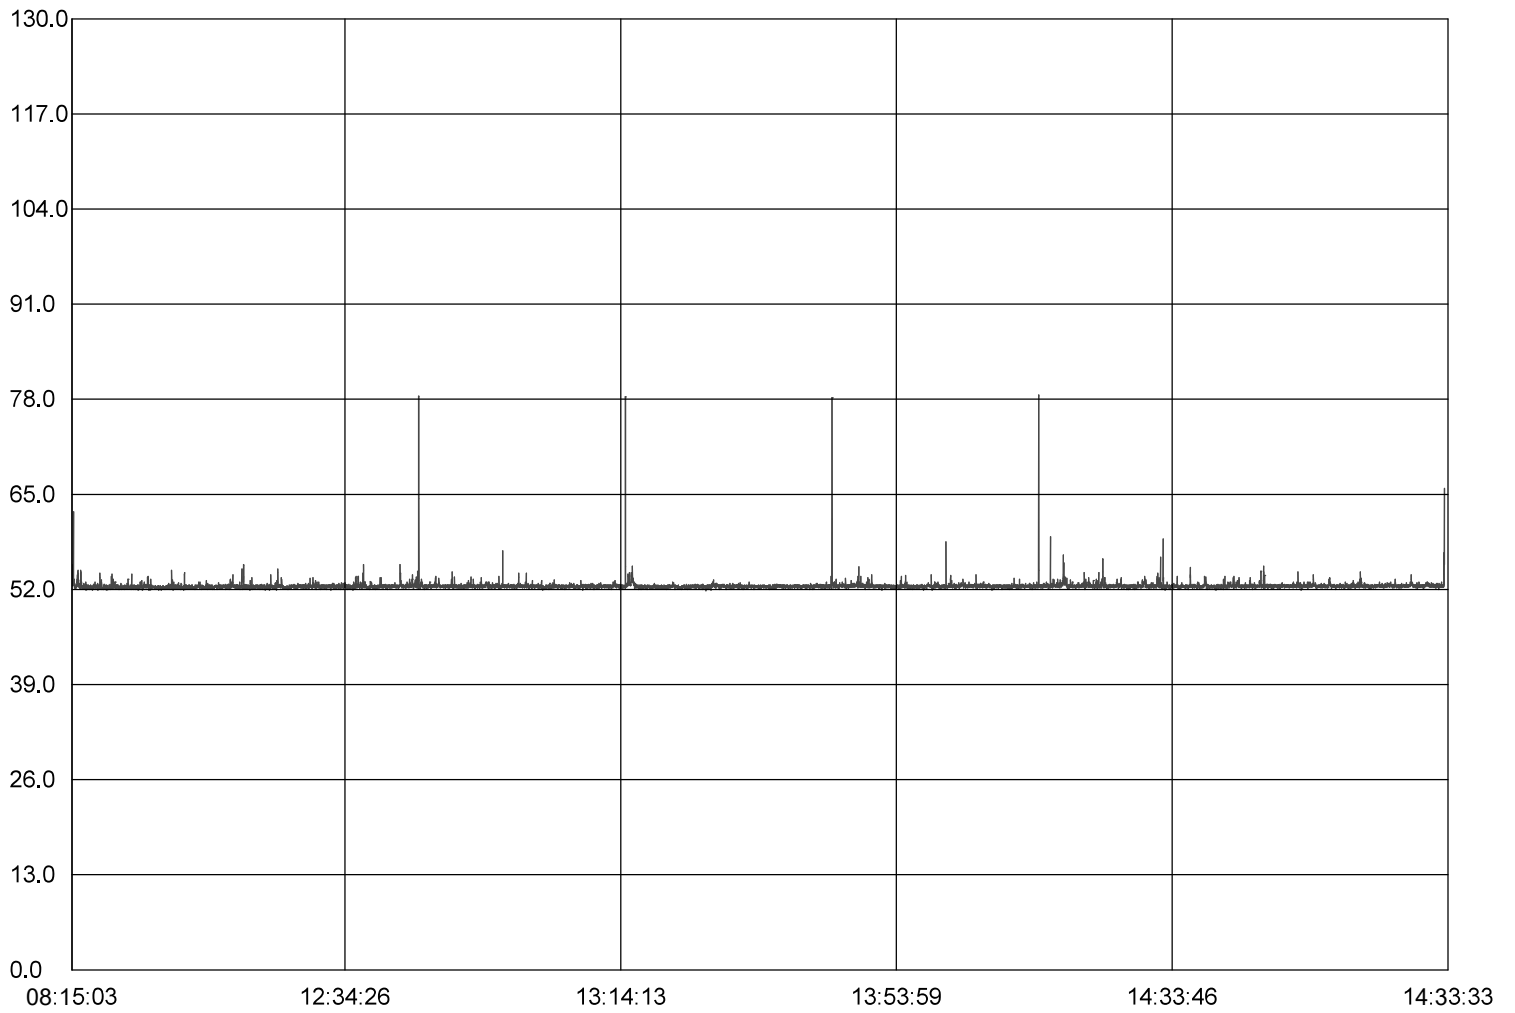
**2nd floor storage**

Standard Sound Level Meter RealTime Graph  
Time: 2019-11-21 14:49:27

Start Time: 21-11-2019,08:15:03  
Maxnum: 78.60 21-11-2019,14:14:31  
Minnum: 51.80 21-11-2019,13:26:32  
Sample Rate: 1.00  
Average: 52.49

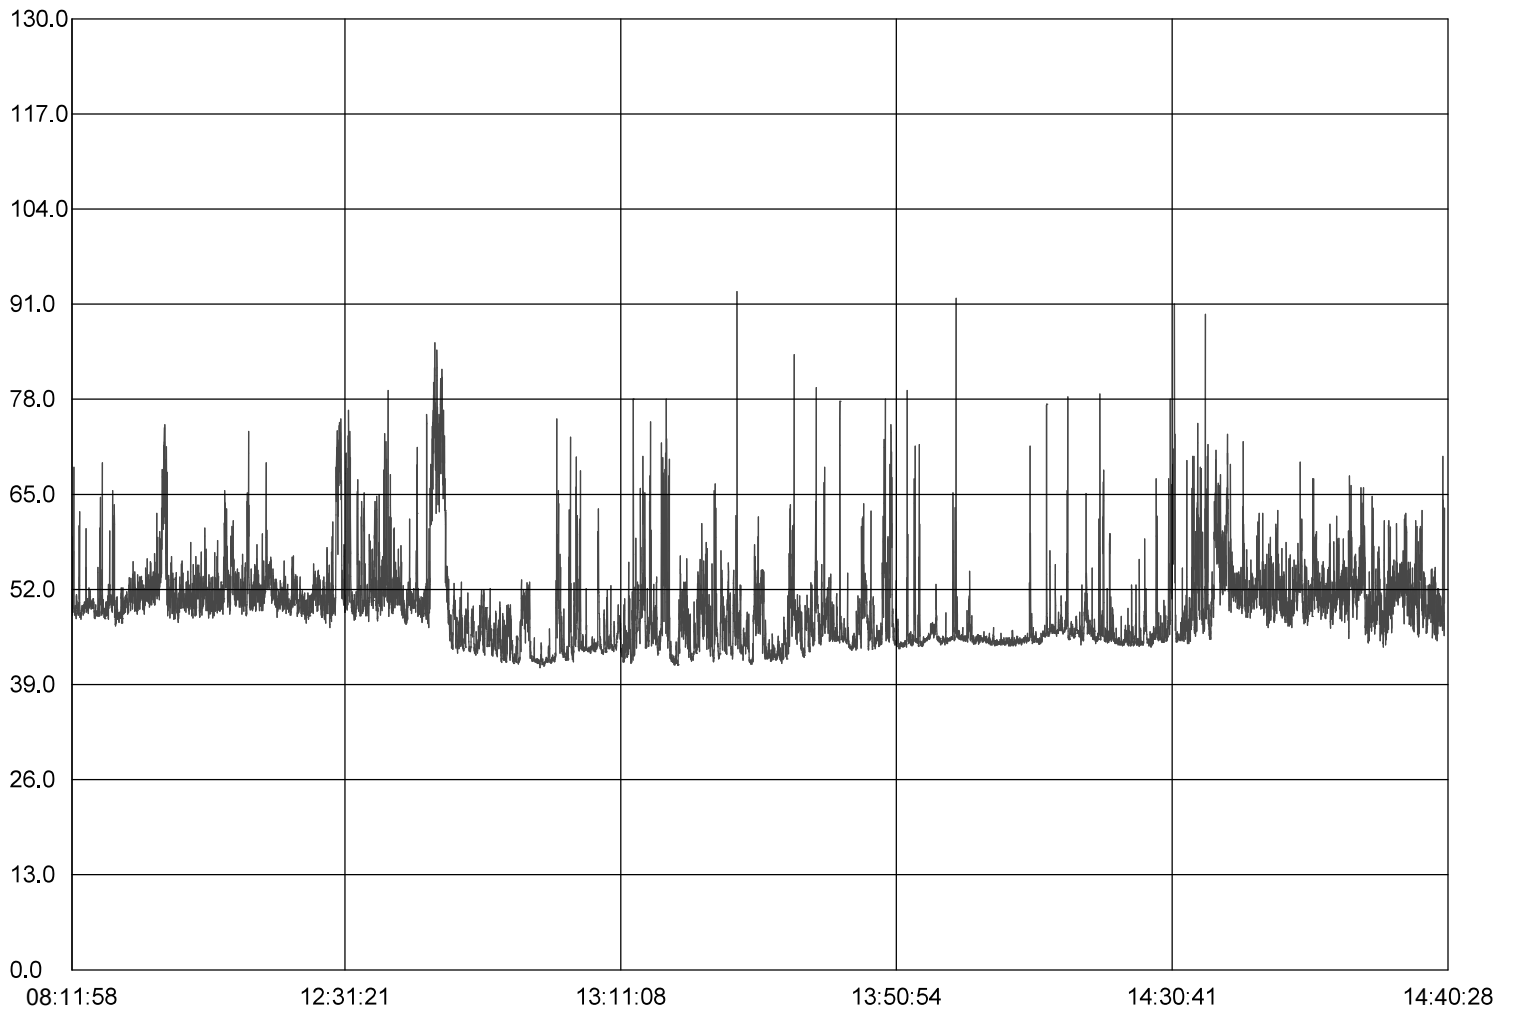
**Basement hallway**

Noise caused by ongoing construction in the perimeter of the school was monitored using a sound level meter. Readings were taken in the basement hallway (20 feet from construction), next to the work performed today.

Standard Sound Level Meter RealTime Graph  
Time: 2019-11-21 14:47:18

Start Time: 21-11-2019,08:11:58  
Maxnum: 92.70 21-11-2019,13:27:55  
Minnum: 41.30 21-11-2019,12:59:29  
Sample Rate: 1.00  
Average: 49.33
