| Project: <b>GREENACRES ELEMENTARY SCHOOL</b> | Date: <b>02.25.2020</b> |

| Inspection Type: <b>NOISE AND DUST MONITOR</b> | | Contractor: | |
| Specific Location: <b>S AND N BASEMENT, 1ST FLOOR, 2ND FLOOR</b> | | | |

## INSPECTION REPORT

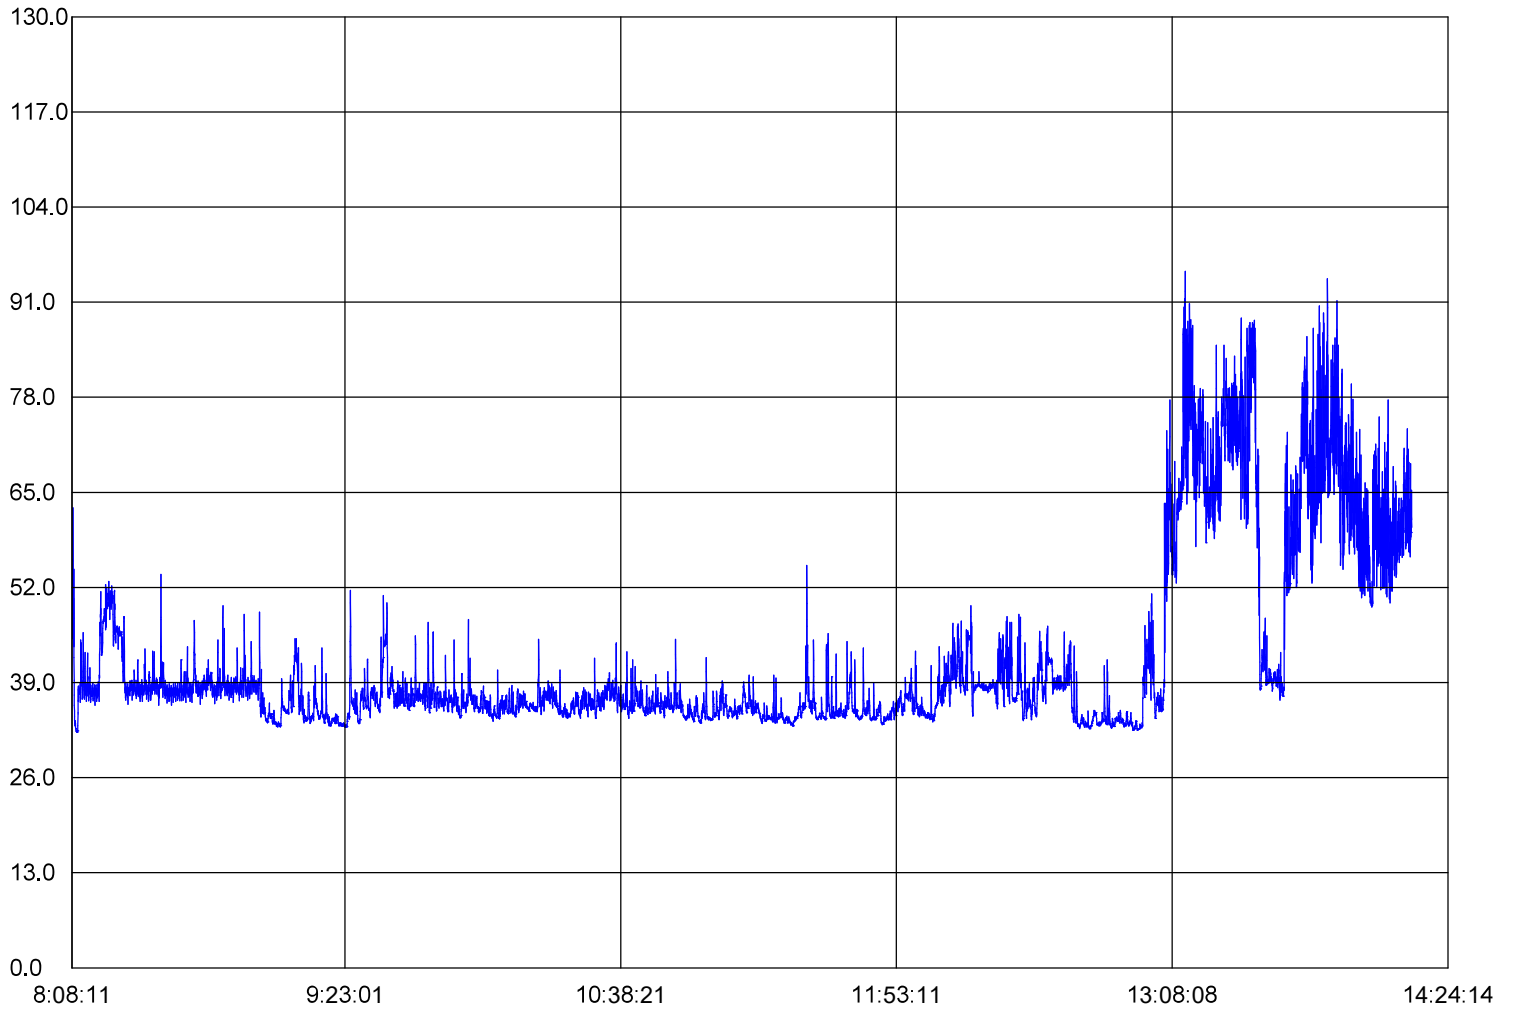
2ND FLOOR STORAGE

Standard Sound Level Meter RealTime Graph  
Time: 2020-2-25 14:49:19

Start Time: 25-02-2020,8:08:11  
Maxnum: 92.50 25-02-2020,13:10:12  
Minnum: 31.30 25-02-2020,10:49:02  
Sample Rate: 1.00  
Average: 45.00

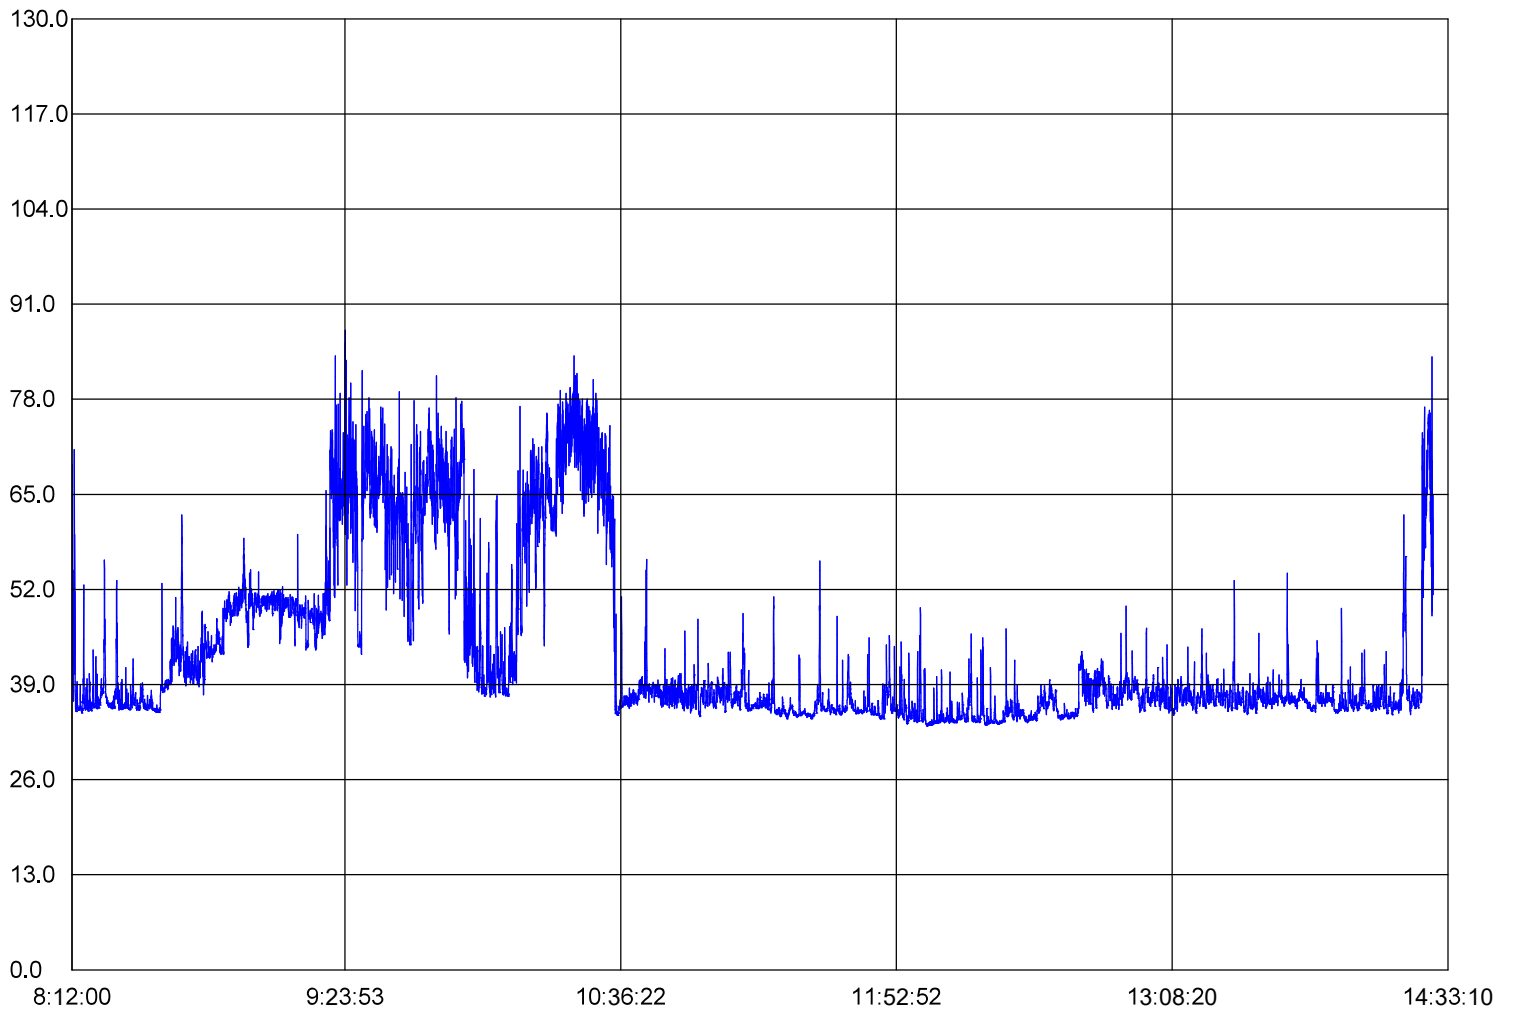
BASEMENT HALLWAY

Standard Sound Level Meter RealTime Graph  
Time: 2020-2-25 14:50:18

Start Time: 25-02-2020,8:12:00  
Maxnum: 83.40 25-02-2020,9:03:10  
Minnum: 31.00 25-02-2020,12:11:30  
Sample Rate: 1.00  
Average: 45.85
